THE GEORGE H. WILLIAMS HOUSE

IL-HABS NO.  
CK-1994-1

Location: 1706 West Jackson Boulevard  
Section 18, Township 39 North,  
Range 14 East, Lots 21, 22, 23, 24

Date of Erection: 1888

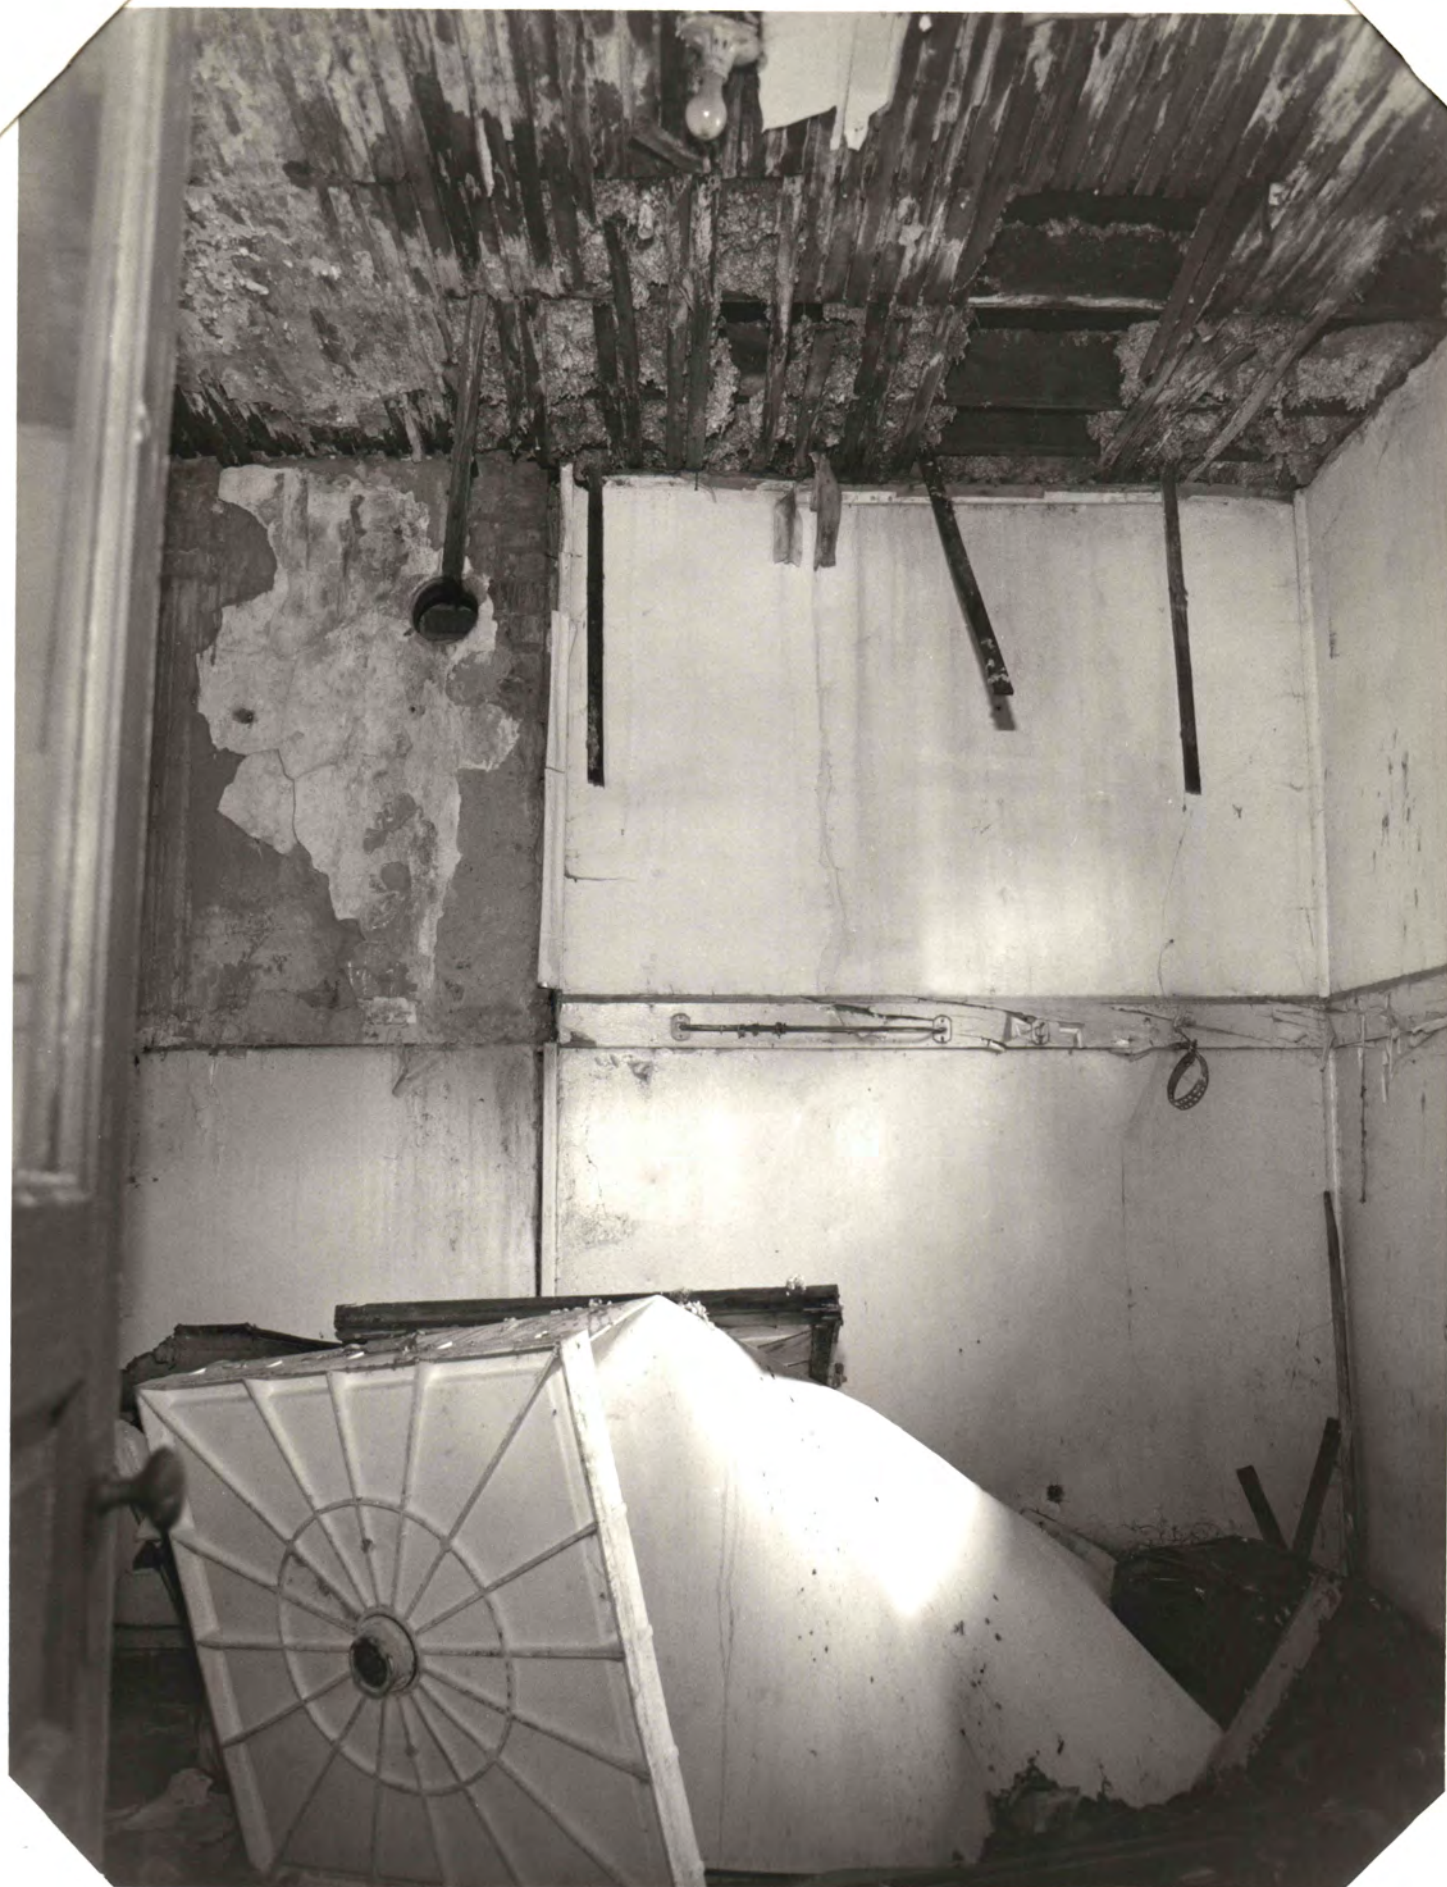
IL HASB N6. (CK-1994-1-19)

- CK-1994-1-17 INTERIOR VIEW OF THIRD FLOOR HALL TO "WORK  
AREA/LAVATORY"
- CK-1994-1-18 INTERIOR VIEW AT THIRD FLOOR LANDING TO BEDROOM  
CHAMBER
- CK-1994-1-19 INTERIOR VIEW OF FIRST FLOOR PARLOR FIREPLACE AND  
RECTANGULAR BAY WINDOW
- CK-1994-1-20 INTERIOR VIEW OF FIRST FLOOR PANTRY AND SERVANT'S  
DOOR
- CK-1994-1-21 INTERIOR VIEW OF THIRD FLOOR ARCHED OPENING BETWEEN  
BEDROOM CHAMBER AND PRESUMED BATH
- CK-1994-1-22 INTERIOR VIEW OF THIRD FLOOR BEDROOM CHAMBER TO  
RECTANGULAR BAY WINDOW
- CK-1994-1-23 INTERIOR VIEW AT SECOND FLOOR STAIR HALL TO PLAYROOM
