**IL-HABS Documentation
of the Moore-Knobeloch Farmstead (IL HABS No. S-2007-2),
Shiloh Valley Township, St. Clair County, Illinois**

Cover Document
Moore-Knobeloch Farmstead
SE¼, NW¼, SE¼ of Section 19
Shiloh Valley Township
St. Clair County
Illinois

IL HABS No. S-2007-2

MOORE-KNOBELOCH FARMSTEAD
IL HABS No. S-2007-2

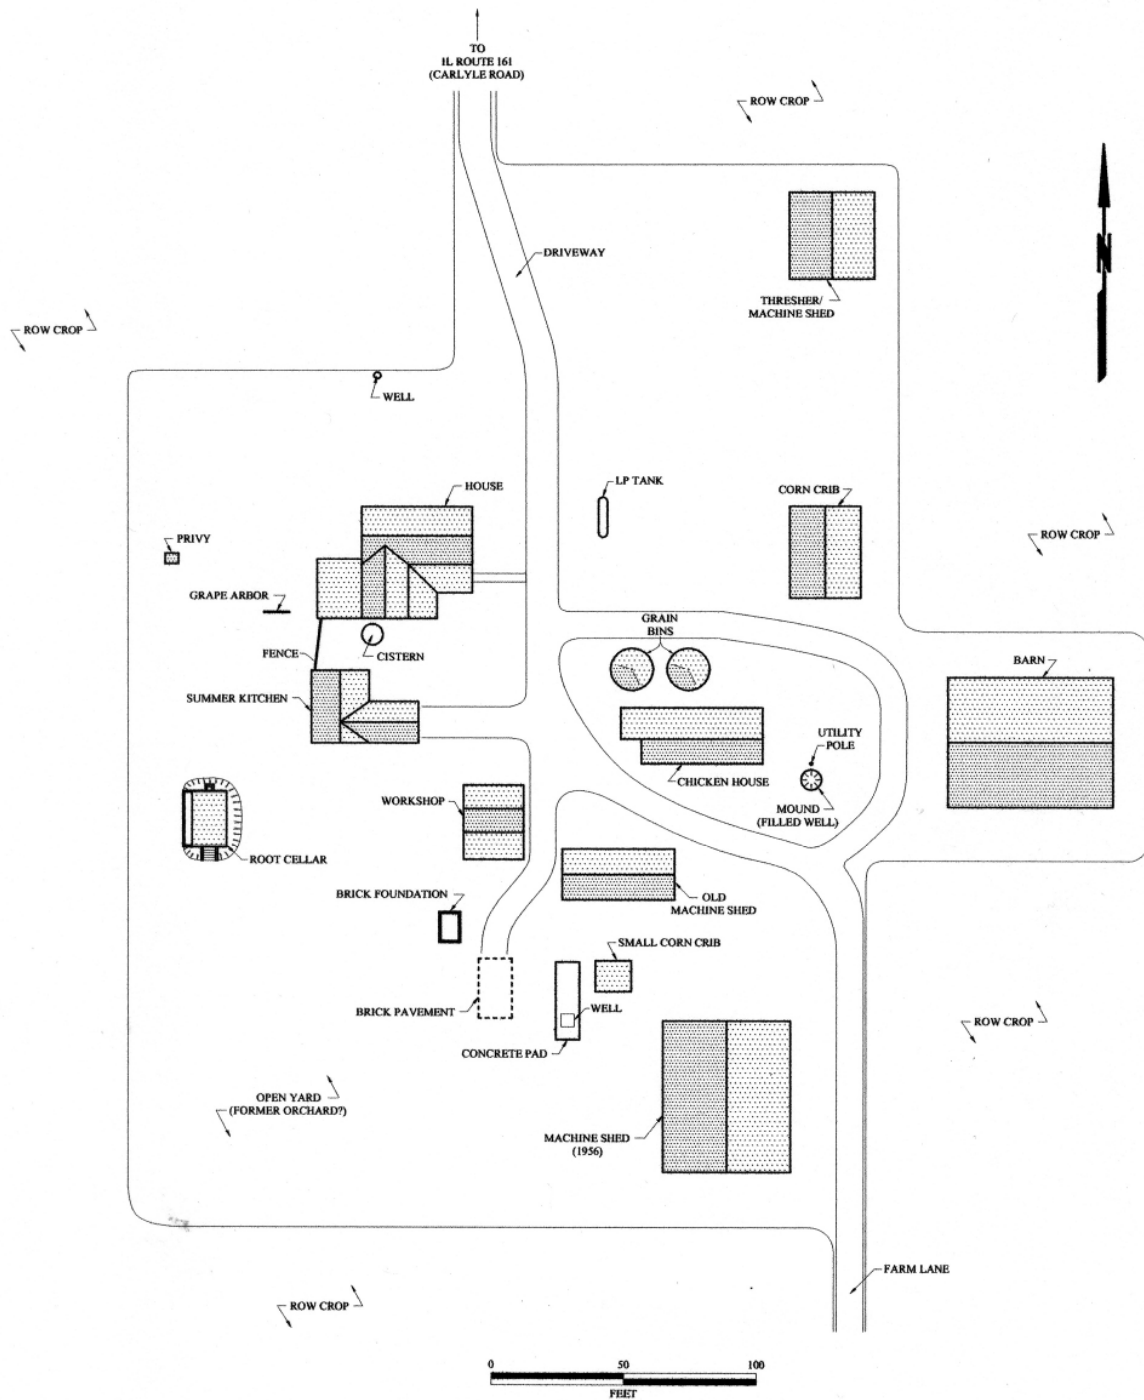
Figure 2. Site plan of the Moore-Knobeloch Farmstead illustrating buildings and structure present and landscape conditions in 2007.

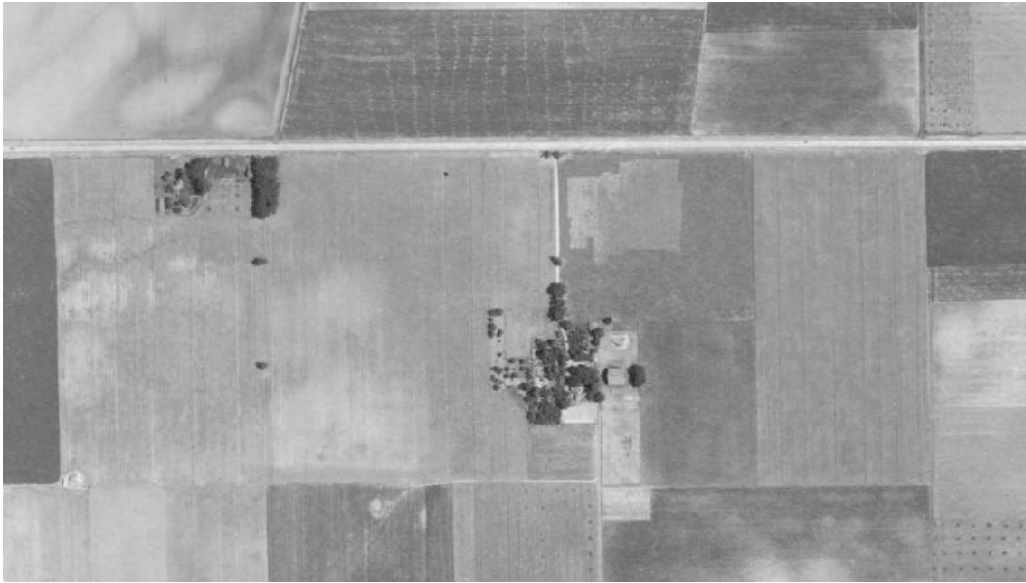
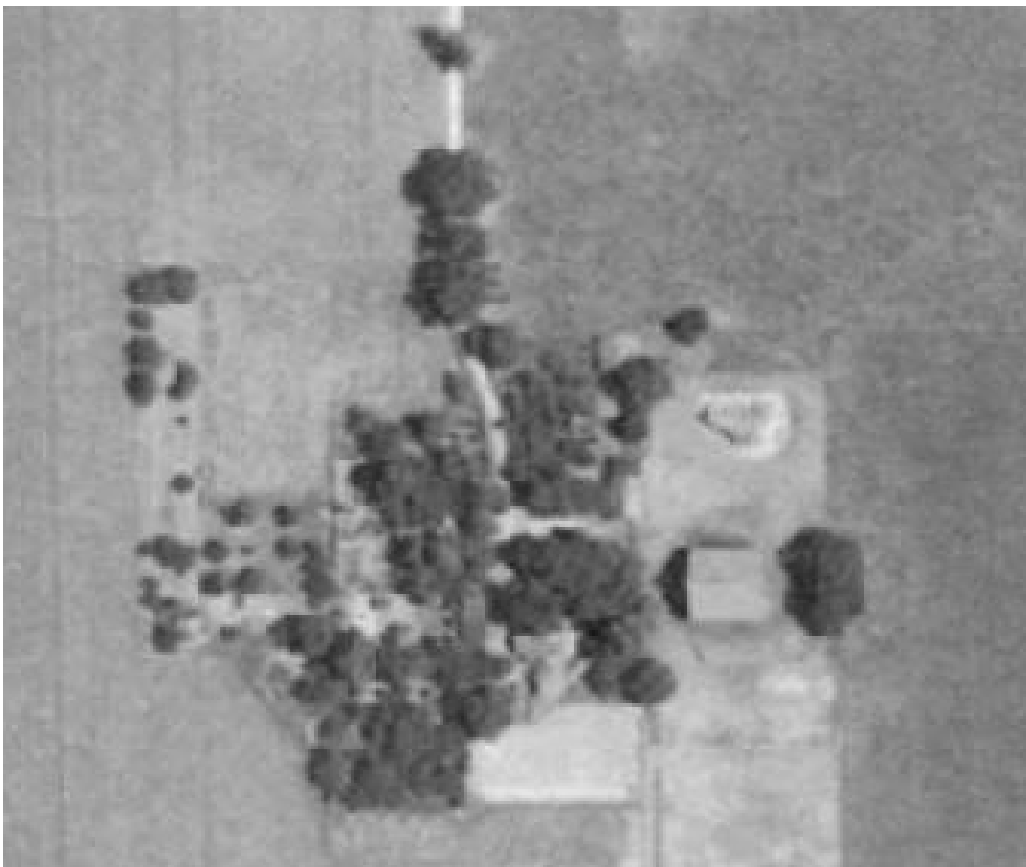
Two views of a 1940 aerial photograph illustrating the Moore-Knobeloch Farmstead. The large building shown at right in the lower view is the barn at the farmstead. Considerable pasturage is shown around the barn. The aerial photograph also suggests that the farmstead had more trees at this date than it presently does.

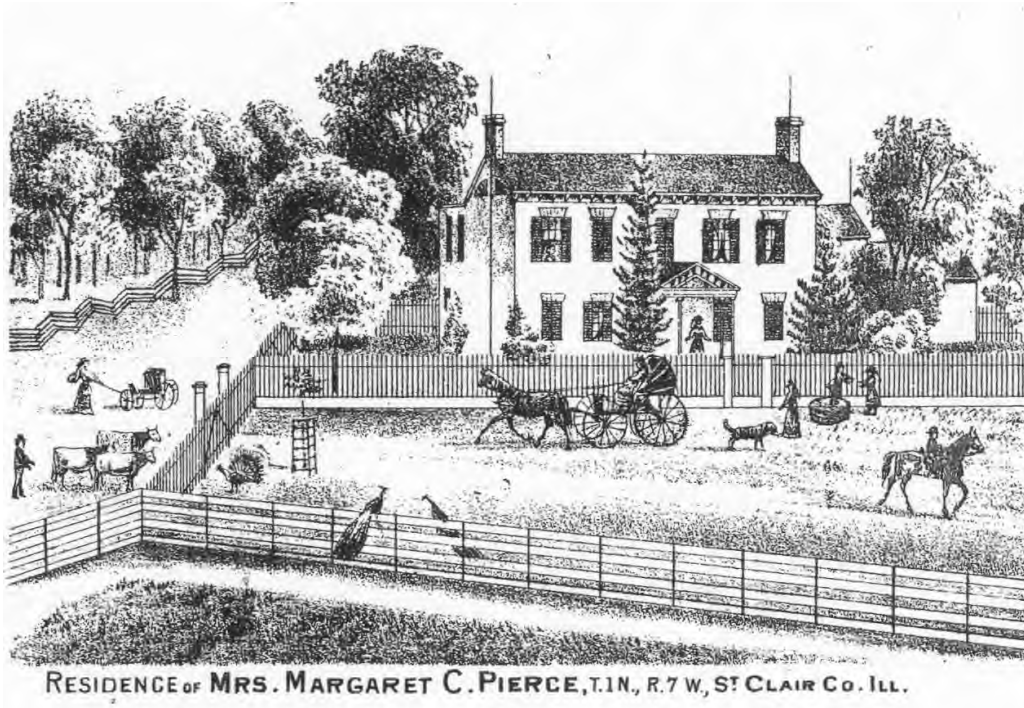
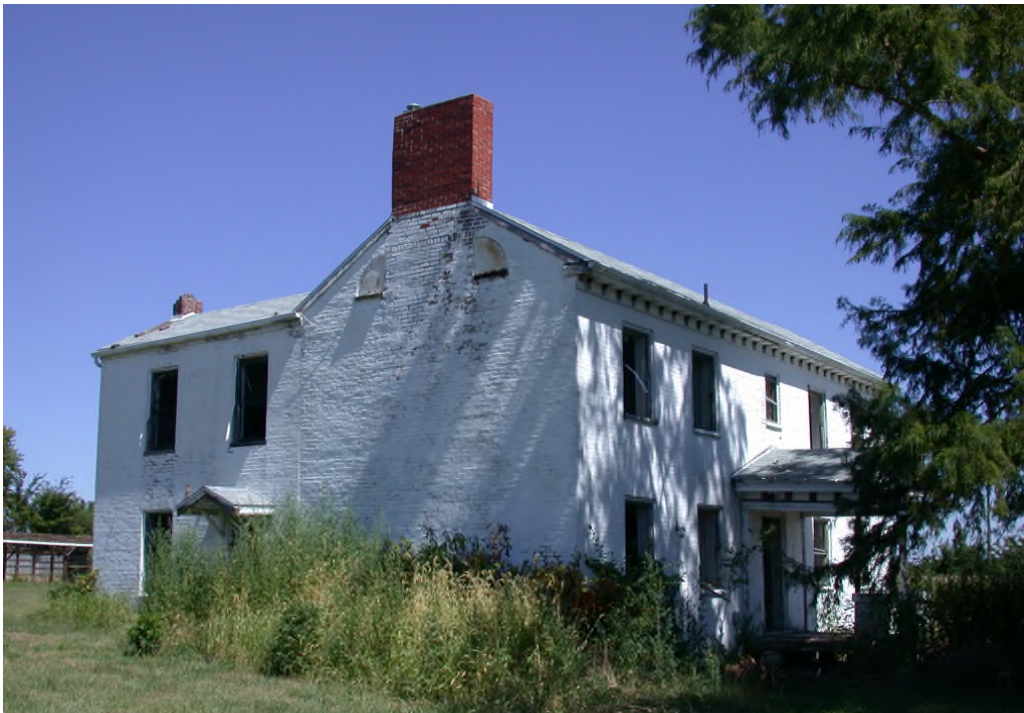
(TOP) An 1874 lithograph of the residence of Mrs. Margaret Pierce in Section 9 of Township 1 North, Range 7 West. This residence is an early example of a brick I-House in Shiloh Valley. **(BOTTOM)** View of the same residence in 2007. The rear wing represents a later addition.

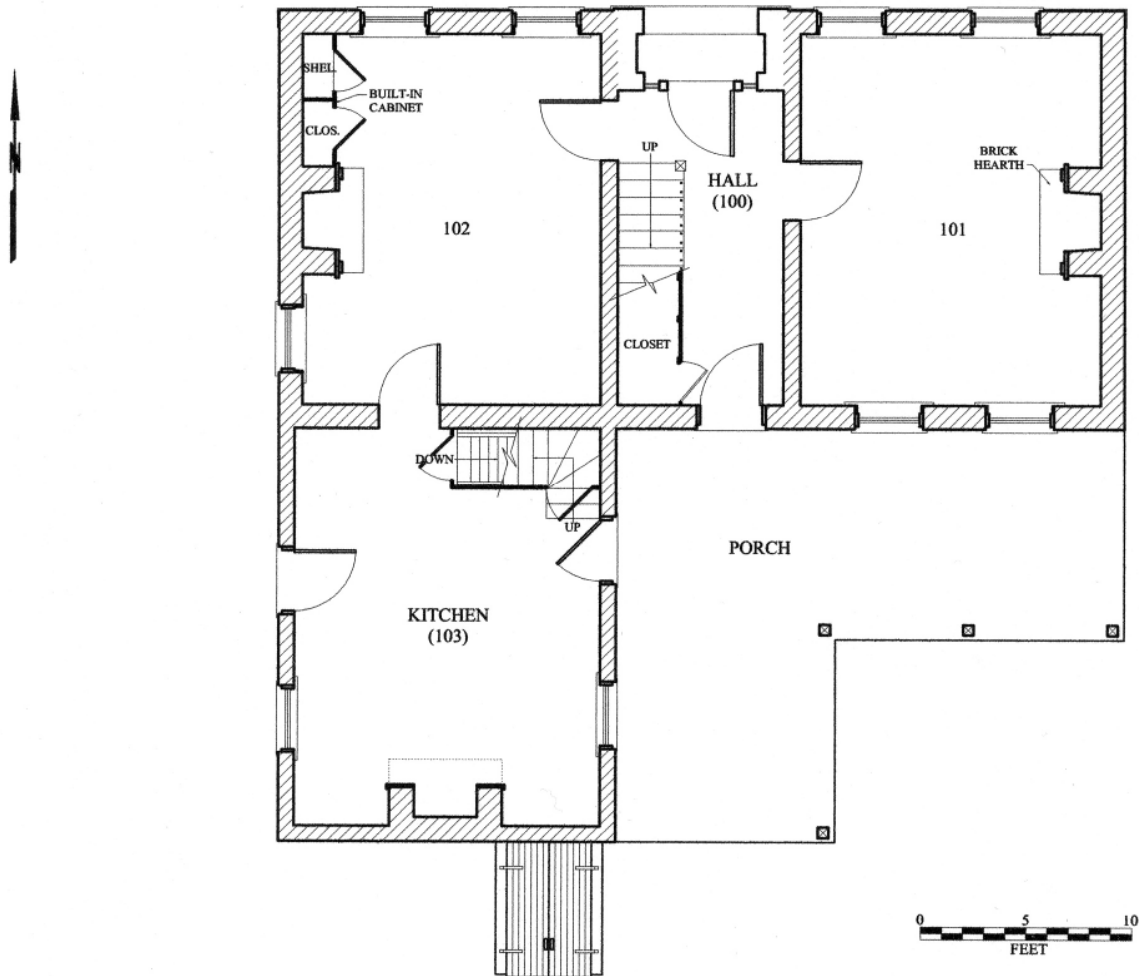
Figure 1. First-floor plan of the house at the Moore-Knobeloch Farmstead, illustrating as-built conditions (circa 1850).

1. Floor Plans: Floor plan drawings of the house are attached as Figures 1 through 9. They illustrate original and present conditions, as well as changes through time. The following textual description is intended to supplement the drawings.

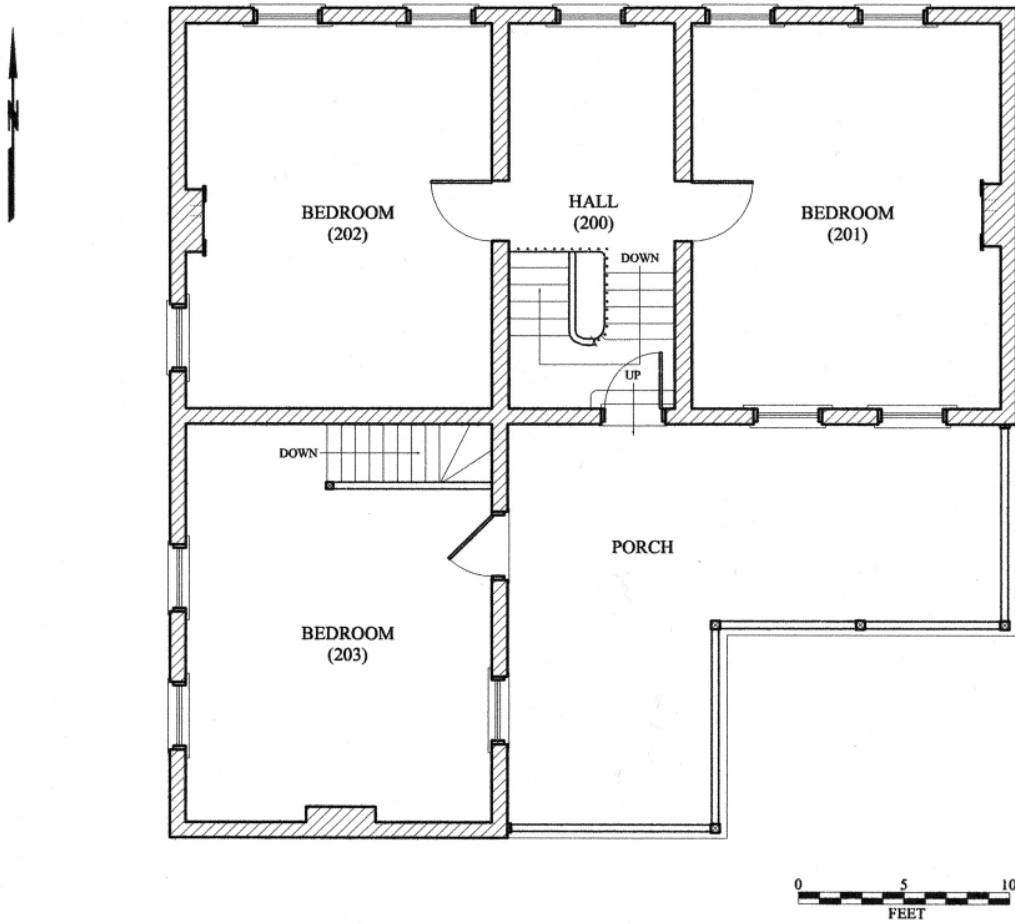
Figure 2. Second-floor plan of the house at the Moore-Knobeloch Farmstead, illustrating as-built conditions (circa 1850).

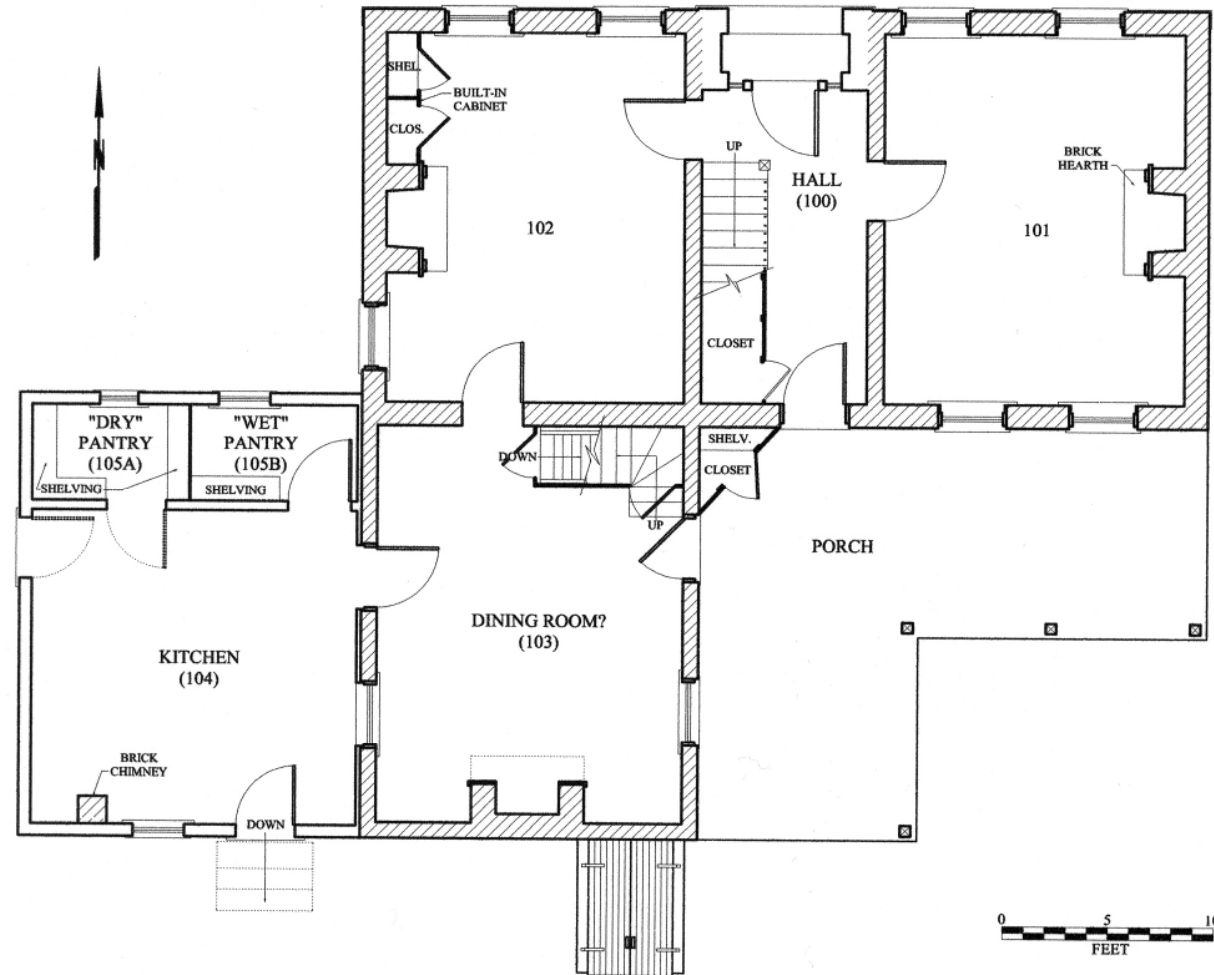
Figure 4. First floor plan of the house illustrating conditions circa 1900, following the addition of the frame kitchen wing on the west side of the dwelling. Note the presence of the “dry” and “wet” pantries on the north end of the new kitchen room.

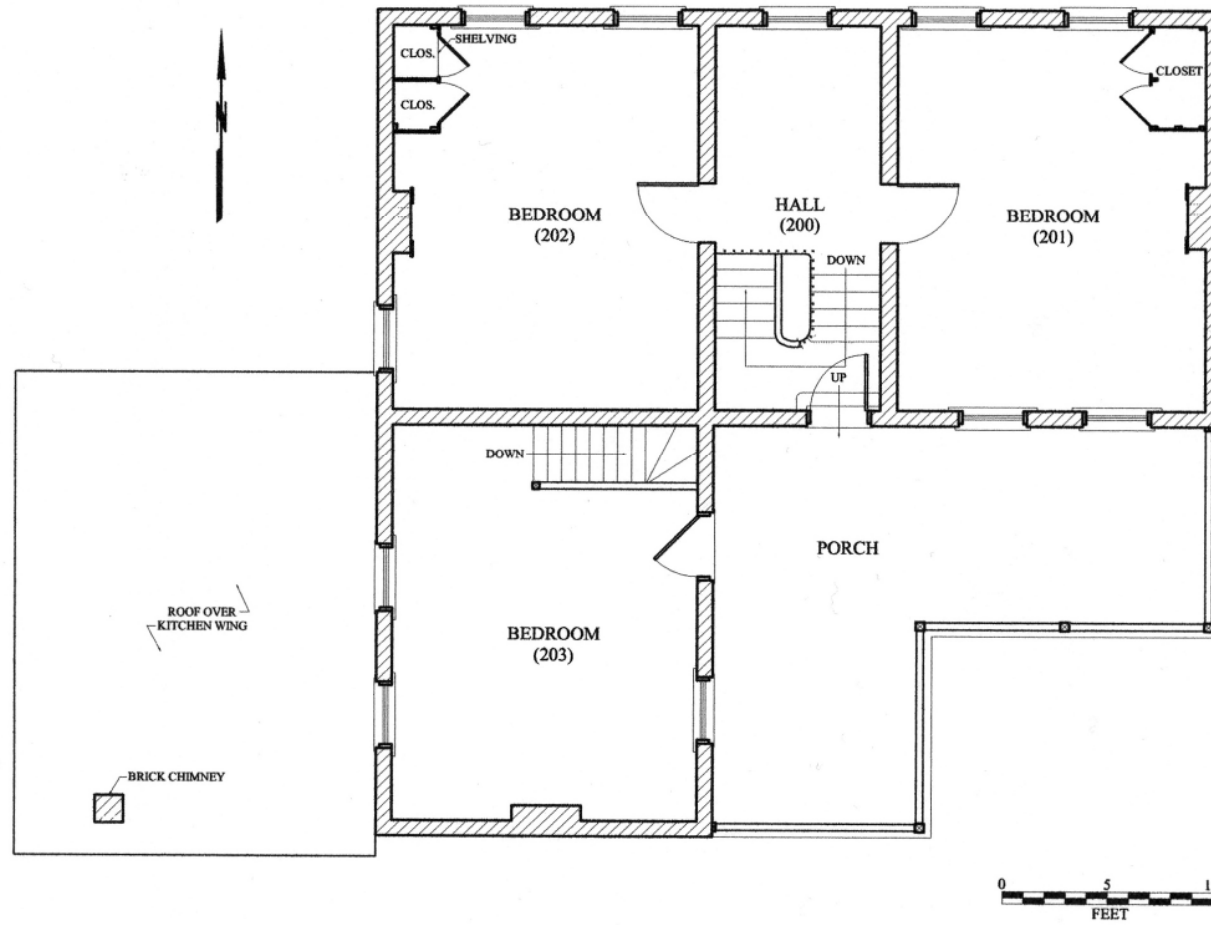
Figure 5. Second-floor plan of the house illustrating conditions circa 1900. By this date, closets had been added to the two bedrooms in the main block.

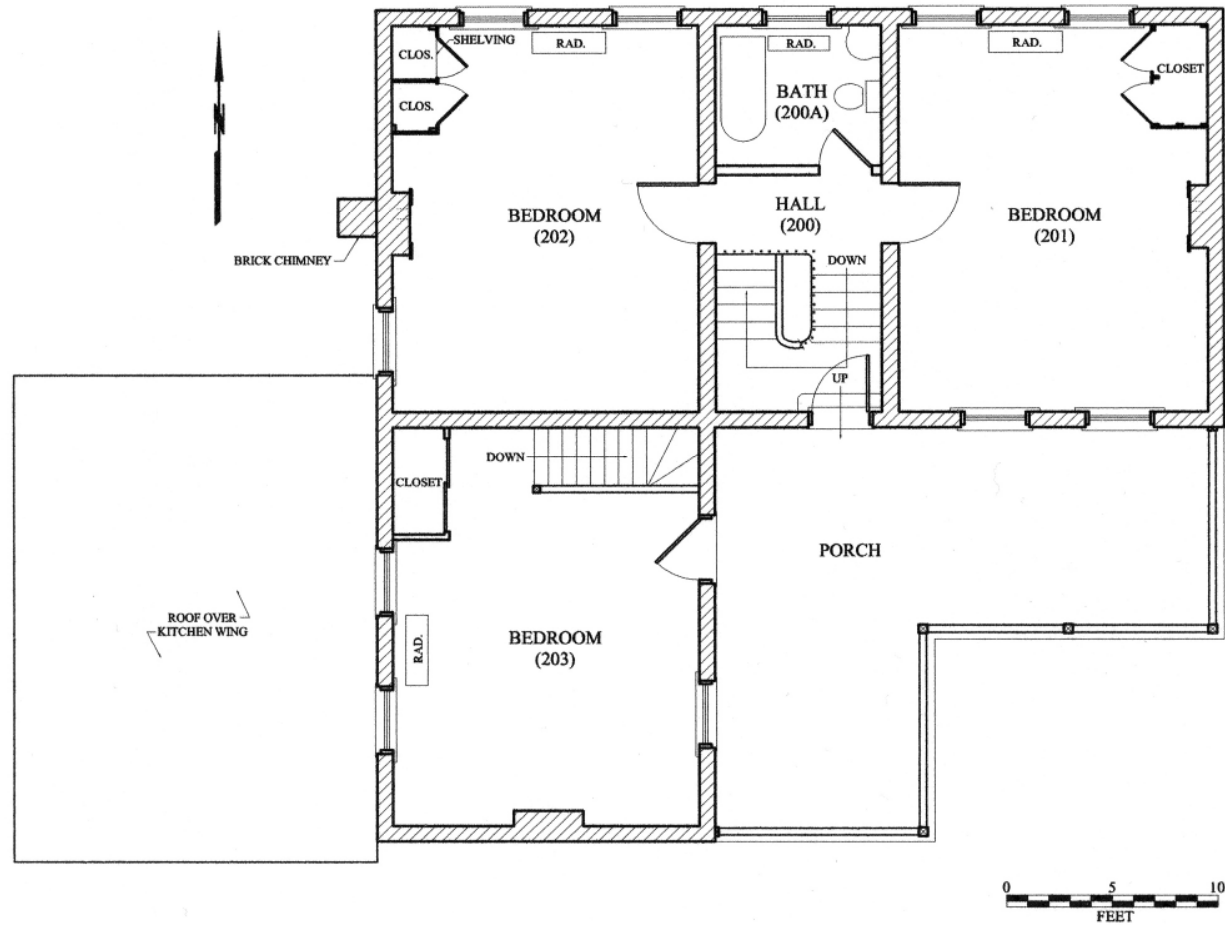
Figure 8. Second-floor plan of the house showing conditions in 2007.

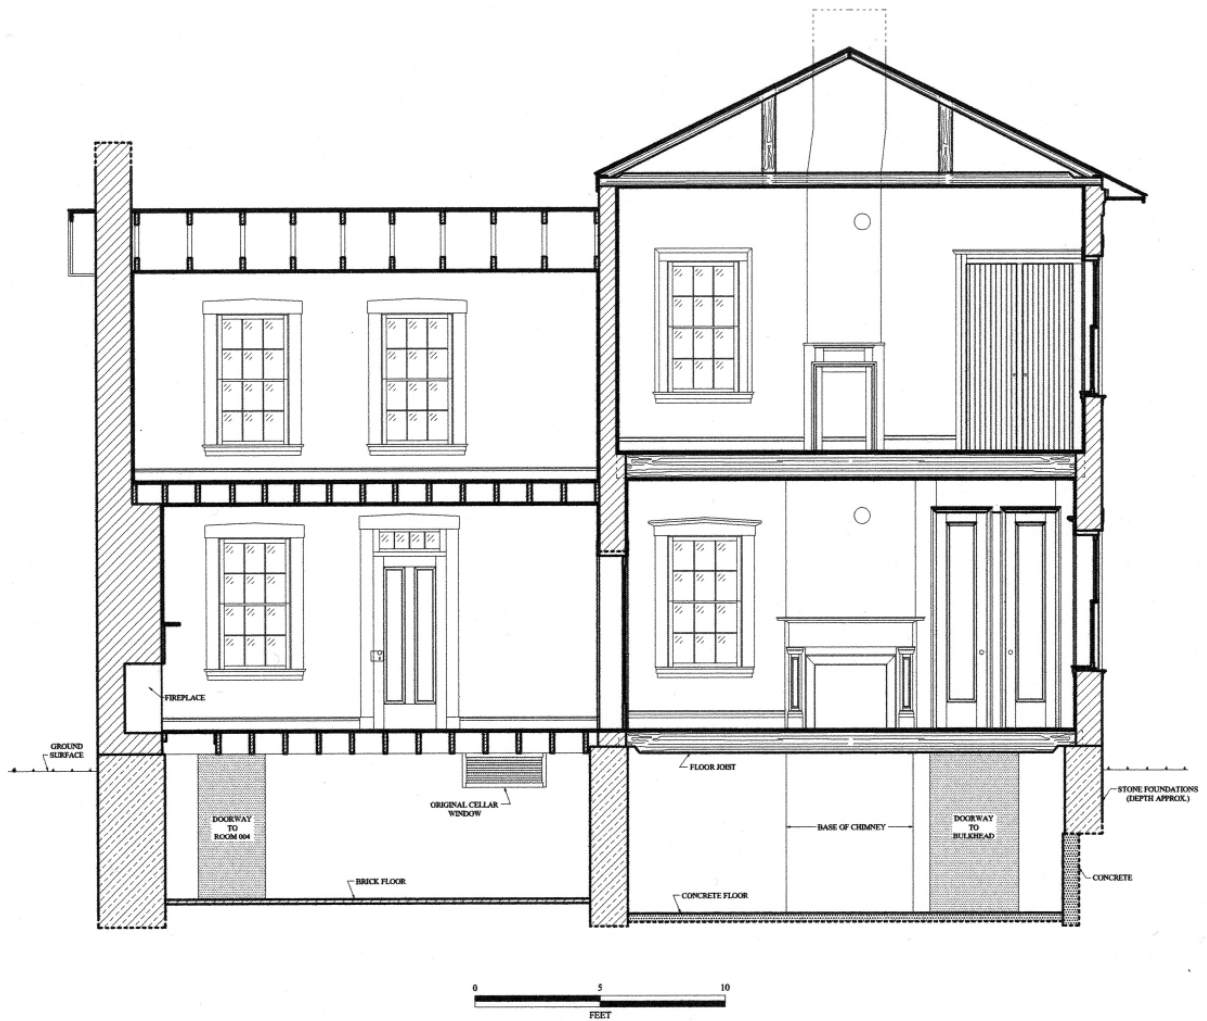
Figure 10. Sectional view of the house, looking through the west end of the dwelling.

² An identical doorway is present on the west side of the rear service wing and connects Rooms 103 and 104. Although now located on the interior of the house, this doorway was an exterior entrance prior to the construction of the frame addition. It is illustrated in the sectional view attached as Figure 10.

Drawings illustrating the mantles present on the first and second floors of the main block are attached as Figures 12 and 13. Additional trim details are provided in the sectional view attached as Figure 10. Various trim profiles are presented in Figures 15 through 18.

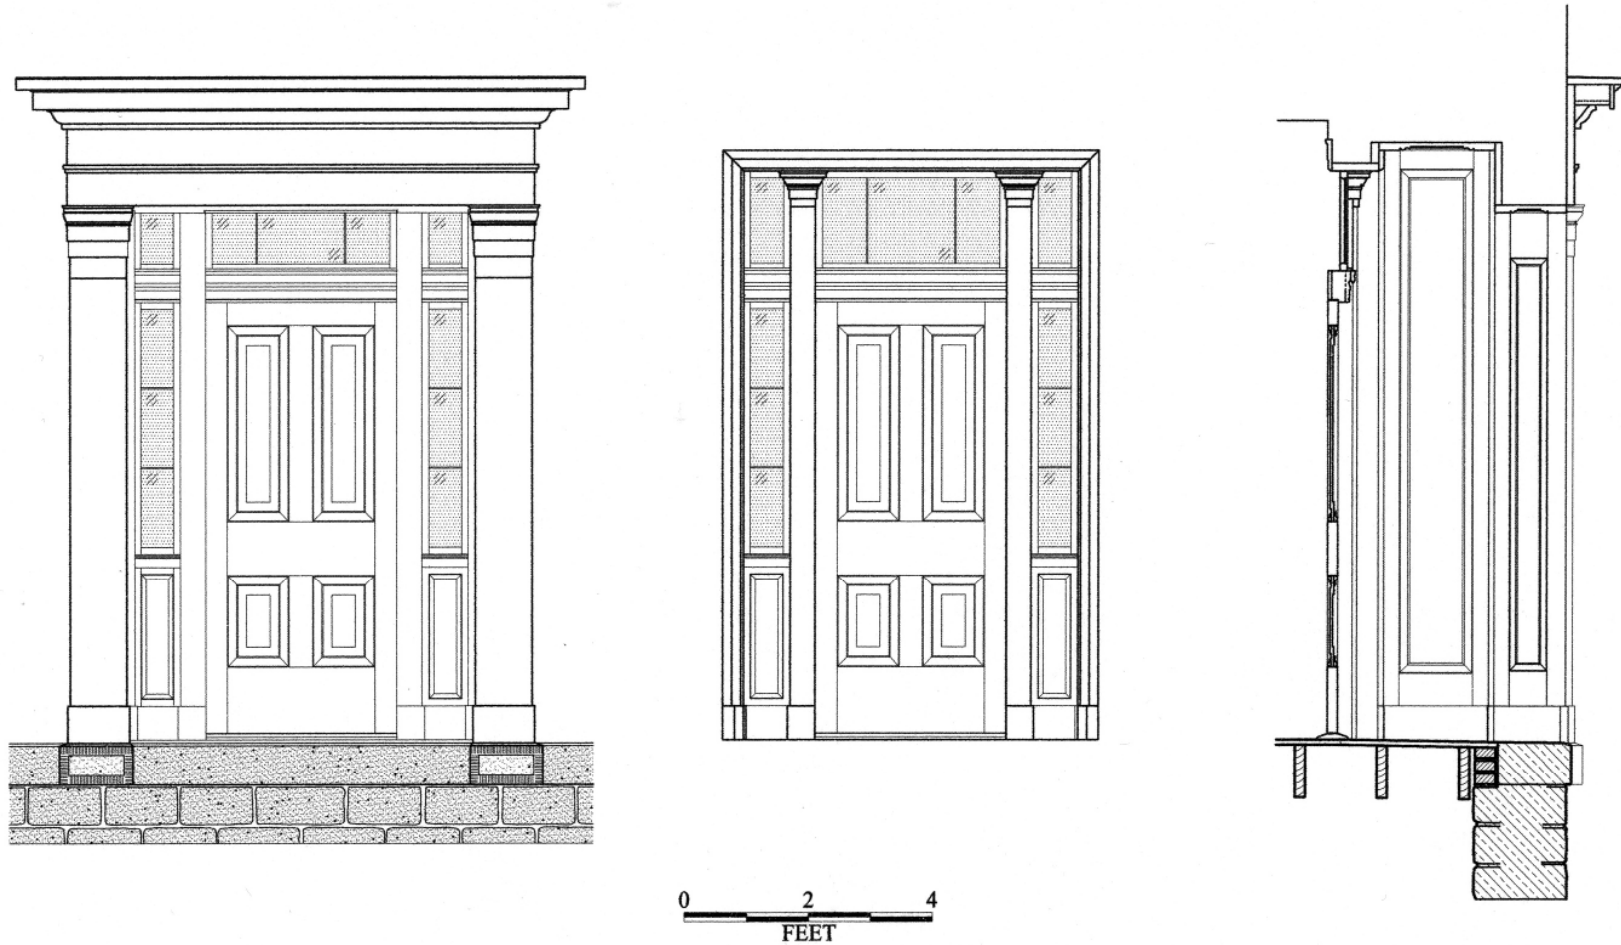
Figure 11. Drawings of the formal entrance on the north elevation of the residence. This entrance is quite ornate and is recessed within the body of the house. The drawing at LEFT shows the front entrance from outside the house, while that in the CENTER illustrates it from within the recessed entranceway. The drawing at RIGHT is a sectional view through the entranceway. Note the paneled side walls.

- a. Doorways and Doors: There are a total of four exterior doorways on the first floor of the house. One of these is the formal entrance on the north elevation of the main block, which has been described to some extent above. This doorway is set within a recessed entranceway with paneled sidewalls and ceiling. It has a four-paneled door that is framed by pilasters, sidelights, and a three-light transom overhead (see Figure 11). The door, which measures 3'-2"x6'-11", is painted on the exterior but stained and varnished on the interior. It opens into a central stair hall (Room 100). At some point in the twentieth century (likely post 1950), a storm door was installed on the outer part of the recessed entranceway. The absence of a porch or stoop at this entrance (or front walk for that matter) suggests that it saw little use during the later decades of the house's occupation, even though it clearly represented the most ornate and impressive of the entries to the home.

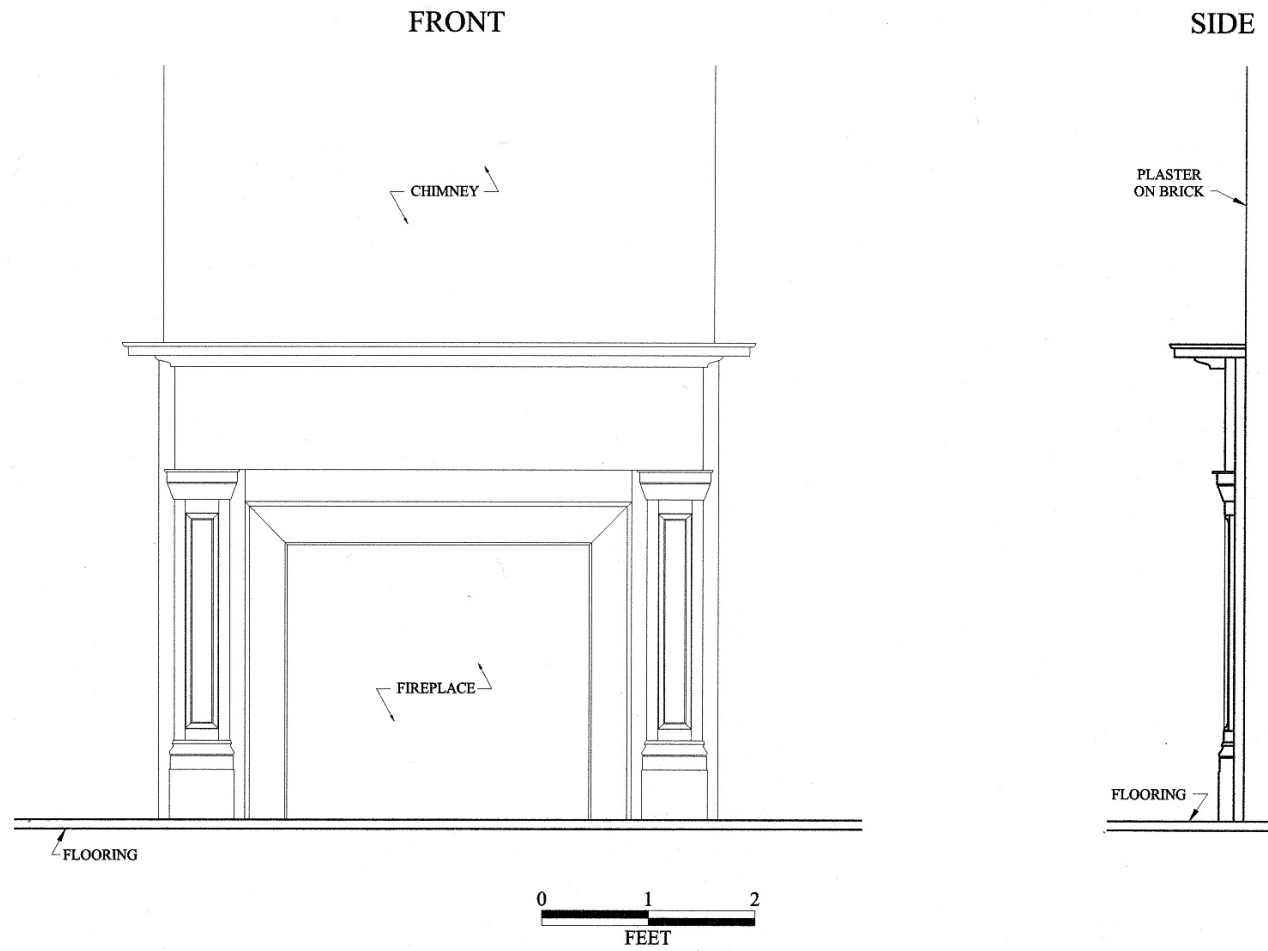
Figure 12. Front and side views of the fireplace mantles present in the two front rooms (101 and 102) on the first floor of the house (Rooms 101 and 102).

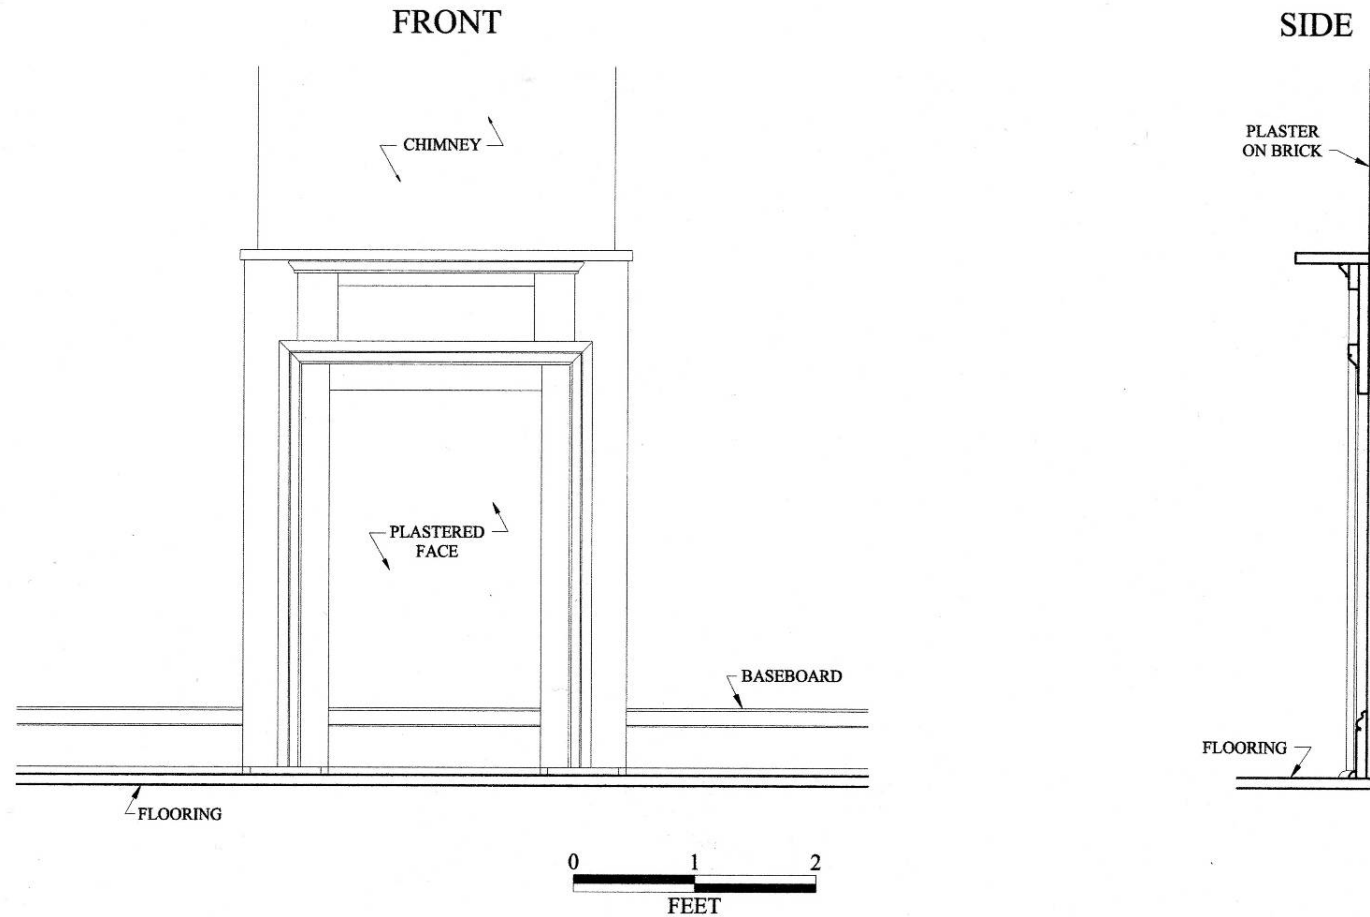
Figure 13. Front and side views of the mantles present in the front bedrooms (Rooms 201 and 202) on the second floor of the house. Unlike those on the first floor, these mantles are not actually associated with fireplaces (the rooms on the upper floor being heated with stoves originally). However, they did provide the illusion of fireplaces being present in Rooms 201 and 202 and thereby provided a significant decorative element to these chambers.

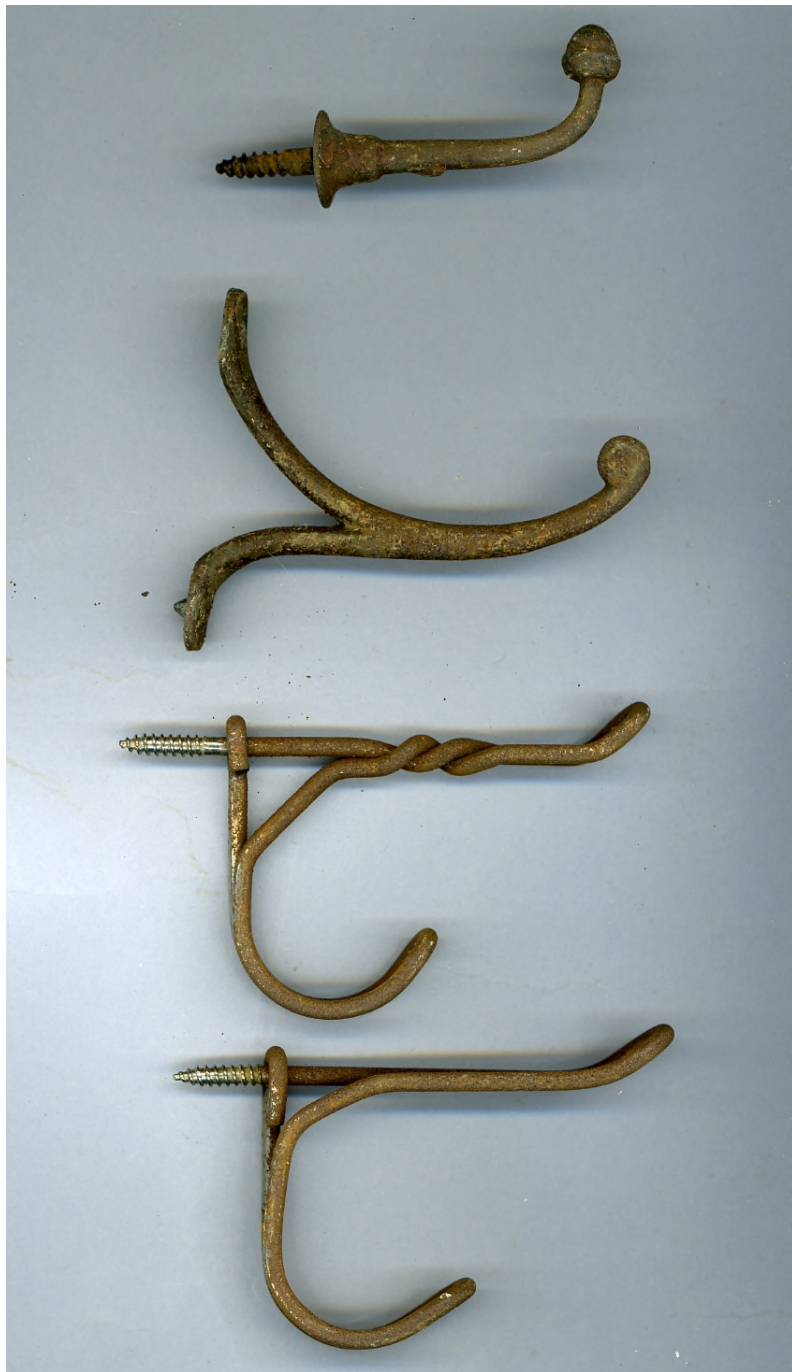
Figure 14. Clothes hooks from the Moore House, St. Clair County, Illinois. Early clothes hooks were cast iron, as represented by the upper two examples. Note the acorn finial on the upper hook. The later nineteenth and twentieth century hooks were constructed of twisted iron wire with screw threads cut onto one end. The hooks are reproduced at 75% their actual size.

7. Hardware: Machine-cut nails were used in the construction of the original house and the frame kitchen addition. Examples of different clothes hooks found in the house are illustrated in Figure 14.

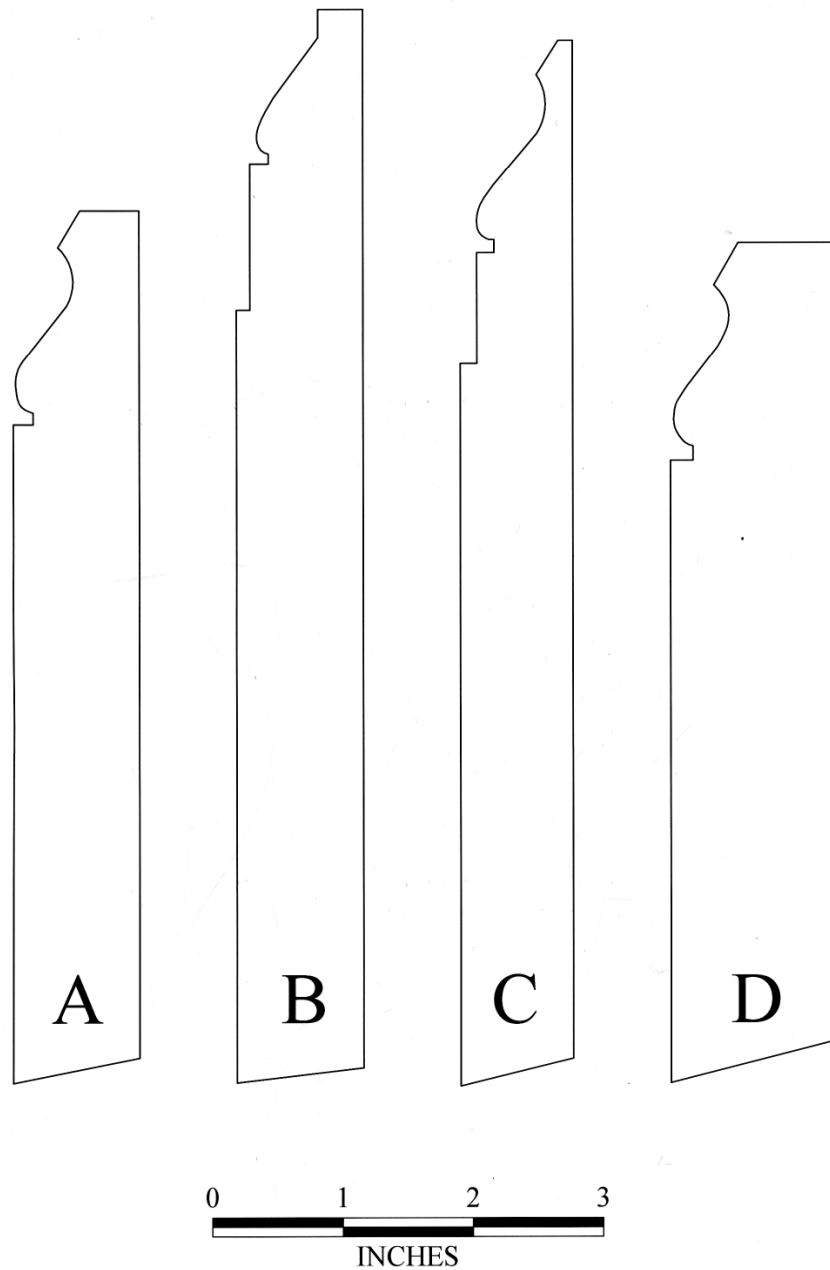
Figure 15. Several styles of baseboard were used in the original section of the Moore House, profiles for which are illustrated above: A) baseboard used in the original kitchen (Room 103), which was painted; B) baseboard used in the first-floor hallway (Room 100), which was oak grained; C) baseboard used in the east parlor (Room 101), originally oak grained and later over painted; and D) baseboard used in the east bedroom on the second floor (Room 201), also oak grained.

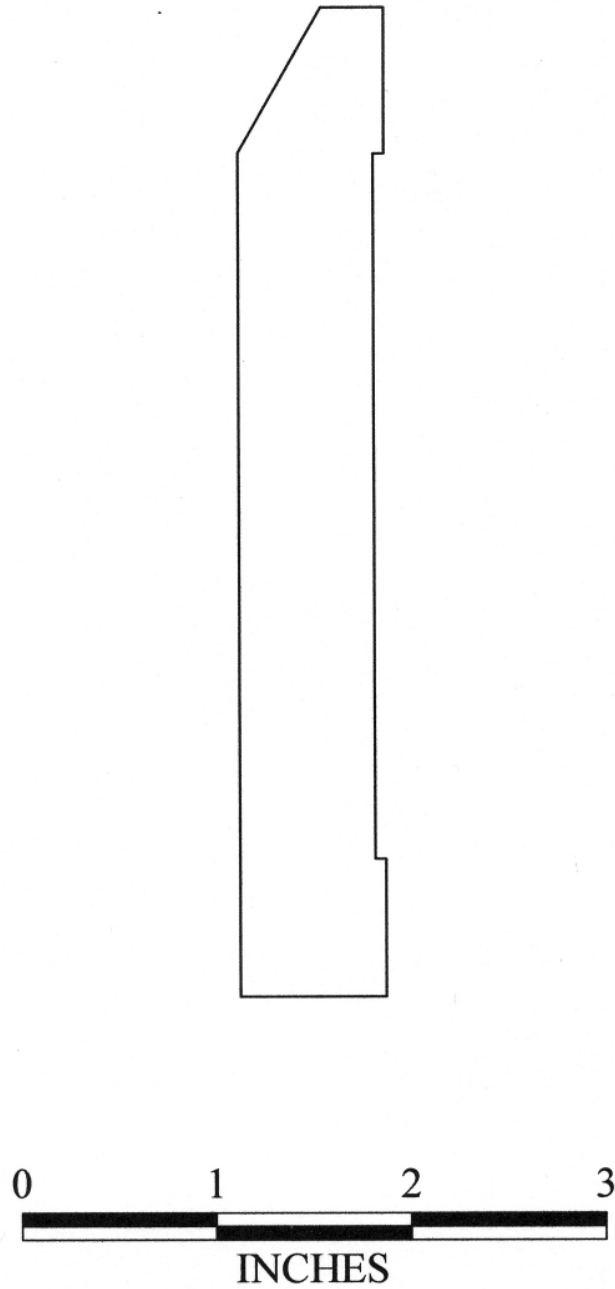
Figure 16. Profile of the baseboard used in the frame kitchen wing built onto the west side of the Moore House circa 1890-1900.

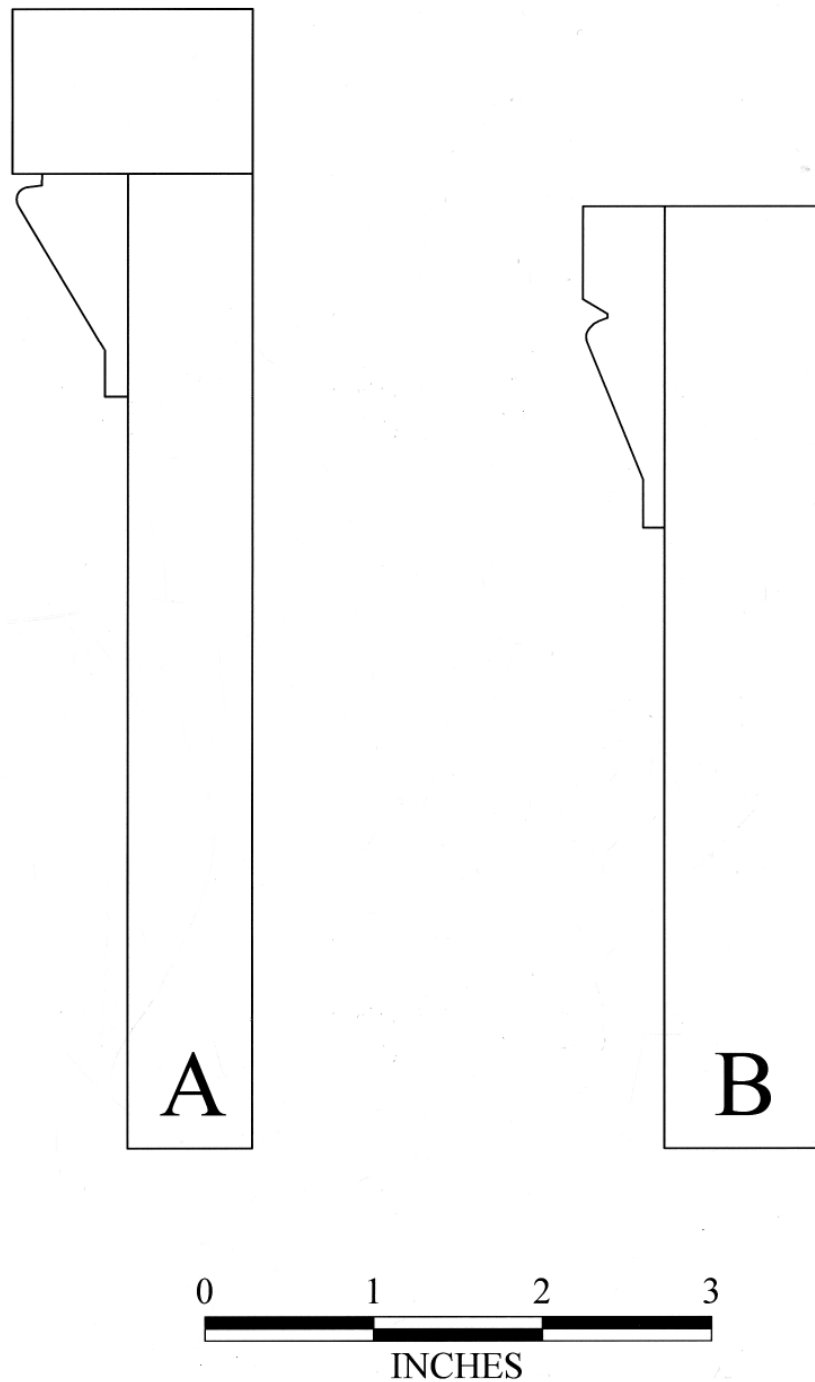
Figure 17. Additional interior trim profiles from the Moore House: A) door and window hoods, which were pedimented and oak grained; and B) jamb trim used on the second-floor openings, also oak grained.

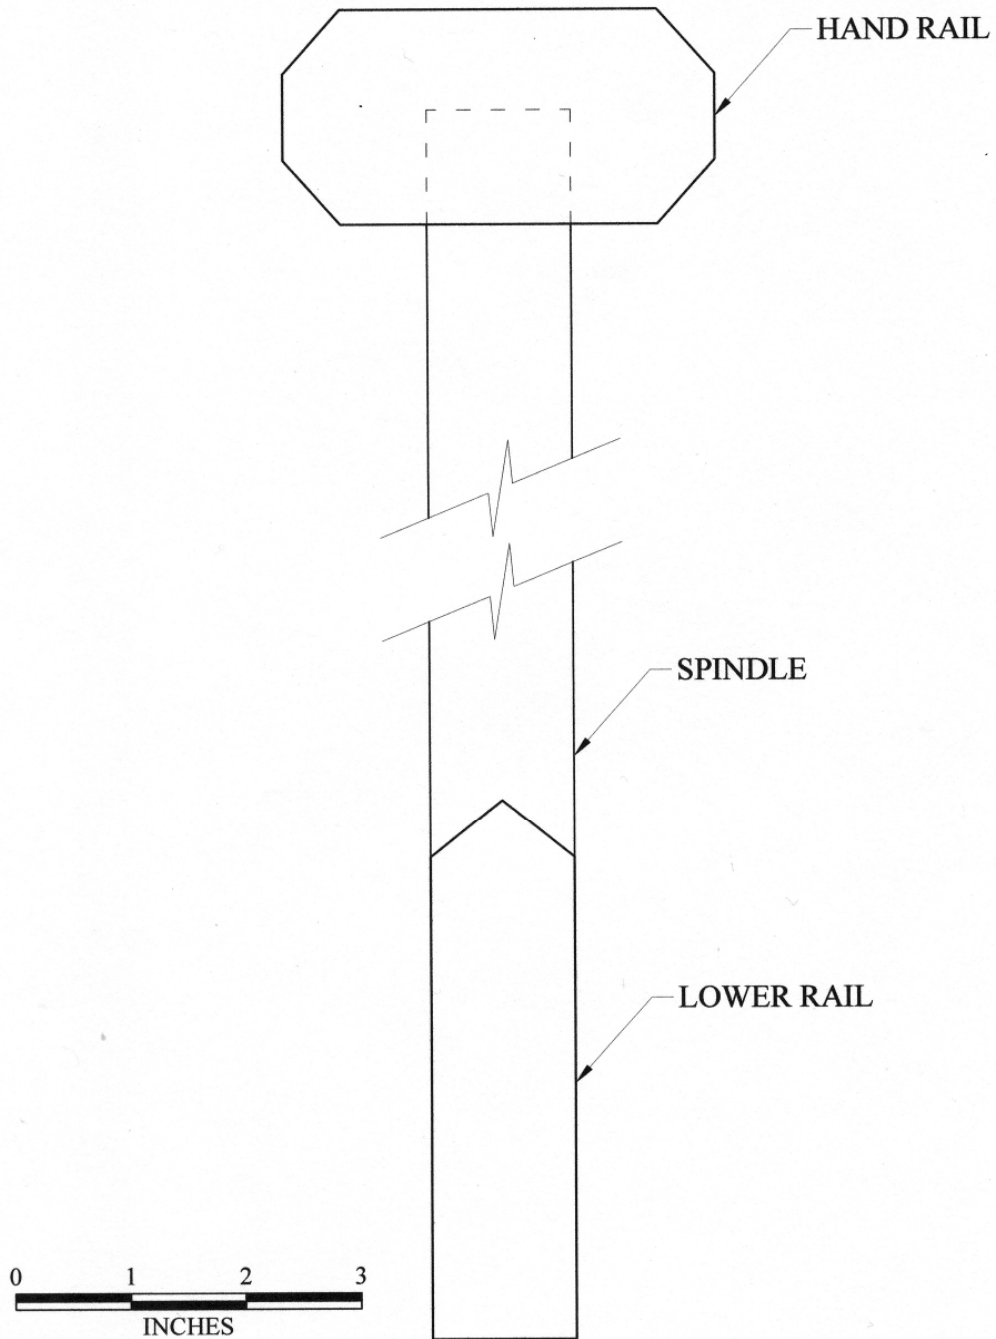
Figure 19. Sectional through the railing used on the upper deck of the rear porch on the Moore House. The spindles were rectangular (5/8"x1-1/4") and were mortised into the handrail and toe-nailed into the lower rail.
