**IL-HABS Documentation
of the Moore-Knobeloch Farmstead (IL HABS No. S-2007-2),
Shiloh Valley Township, St. Clair County, Illinois**

Cover Document
Moore-Knobeloch Farmstead
SE¼, NW¼, SE¼ of Section 19
Shiloh Valley Township
St. Clair County
Illinois

IL HABS No. S-2007-2

MOORE-KNOBELOCH FARMSTEAD
IL HABS No. S-2007-2

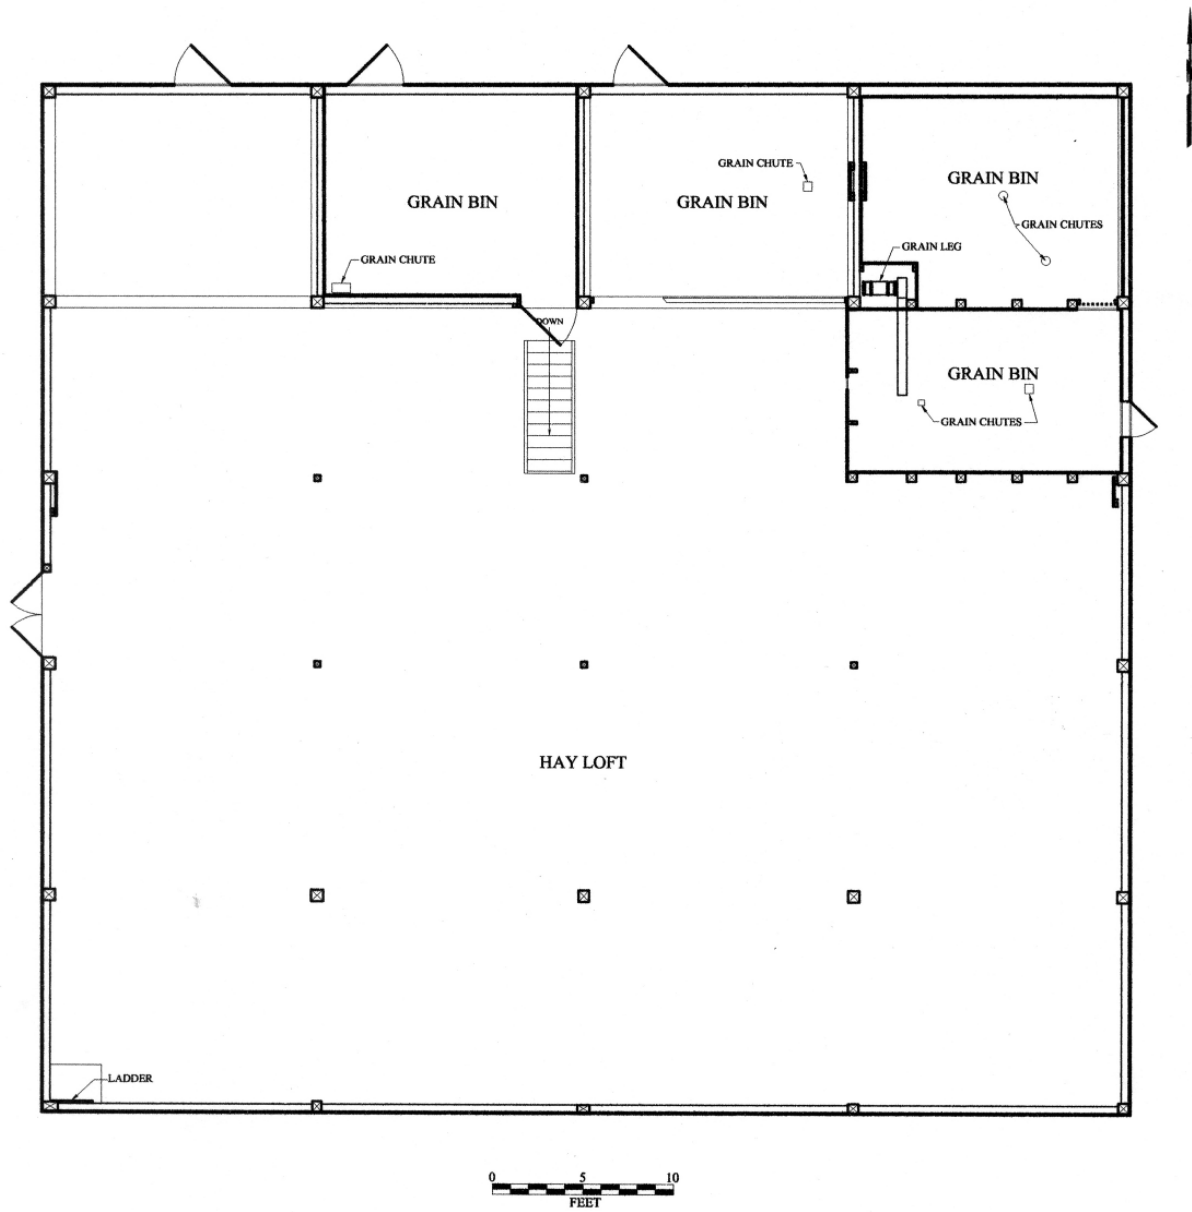
Figure 2. Plan of the upper floor (or haymow level) of the Moore-Knobeloch Barn, showing conditions in 2007.

- b. Second Floor: The majority of the upper floor of the barn is open space and was used as a hayloft (or haymow) historically. A massive amount of hay still remained in the barn at the time of the field investigation. Early in the barn's history, the loft was loaded with loose hay by hand. Following the raising of the roof circa 1909, however, a hay fork was added to the barn. This fork runs along a track, which is attached to the underside of the ridge and projects out beyond the west wall of the barn. The projecting portion of the track is sheltered from the elements by a hay hood. A large mow door is located directly below the hood, and it was through this opening that hay was moved into the barn.

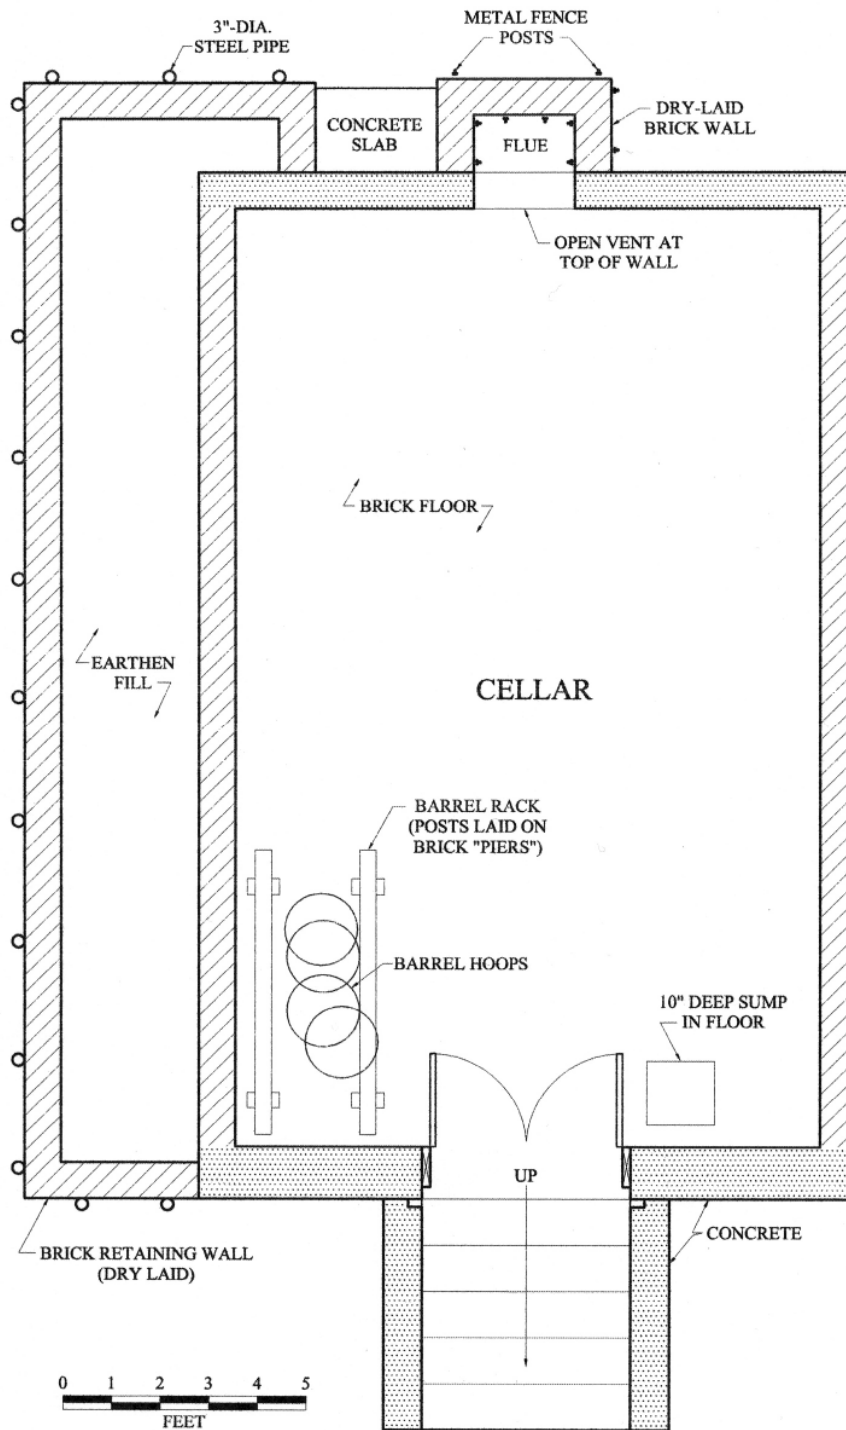
Figure 1. Floor plan of the root cellar at the Moore-Knobeloch Farmstead, showing conditions in 2007.

1. Overall Dimensions: The root cellar measures 21'-4" (north/south) by 13'-6" (east/west).
2. Foundations: The foundations are brick.
3. Walls: The walls of the root cellar mostly are constructed of brick, the exceptions being the upper part of the north and south walls, which are of poured concrete and were added in 1913. The brickwork on the north, east, and west walls is two courses thick while that on the south is three courses. The brick is laid in common bond.
4. Structural System, Framing: The cellar is of masonry construction. In 1913 the original brick barrel arch was removed and replaced by a straight-walled, flat-roofed configuration. New brickwork and poured concrete was laid upon the original walls that were retained, and a concrete roof was poured.

1. Floor Plans: The cellar consists of a single open room measuring 19'-6"x12'-0." A barrel rack is located in the southwest corner of the cellar. The rack consists of two parallel 4"x4" posts set on bricks to keep them off the floor. Iron rings, or hoops, from the barrels once stored here are scattered around the rack (the wood staves having deteriorated). A 1-1/2"-diameter pipe extends across the width of the cellar at its north (rear) end. This pipe possibly was to hang things from or perhaps served as some type of rack support. See attached floor plan for more detail.

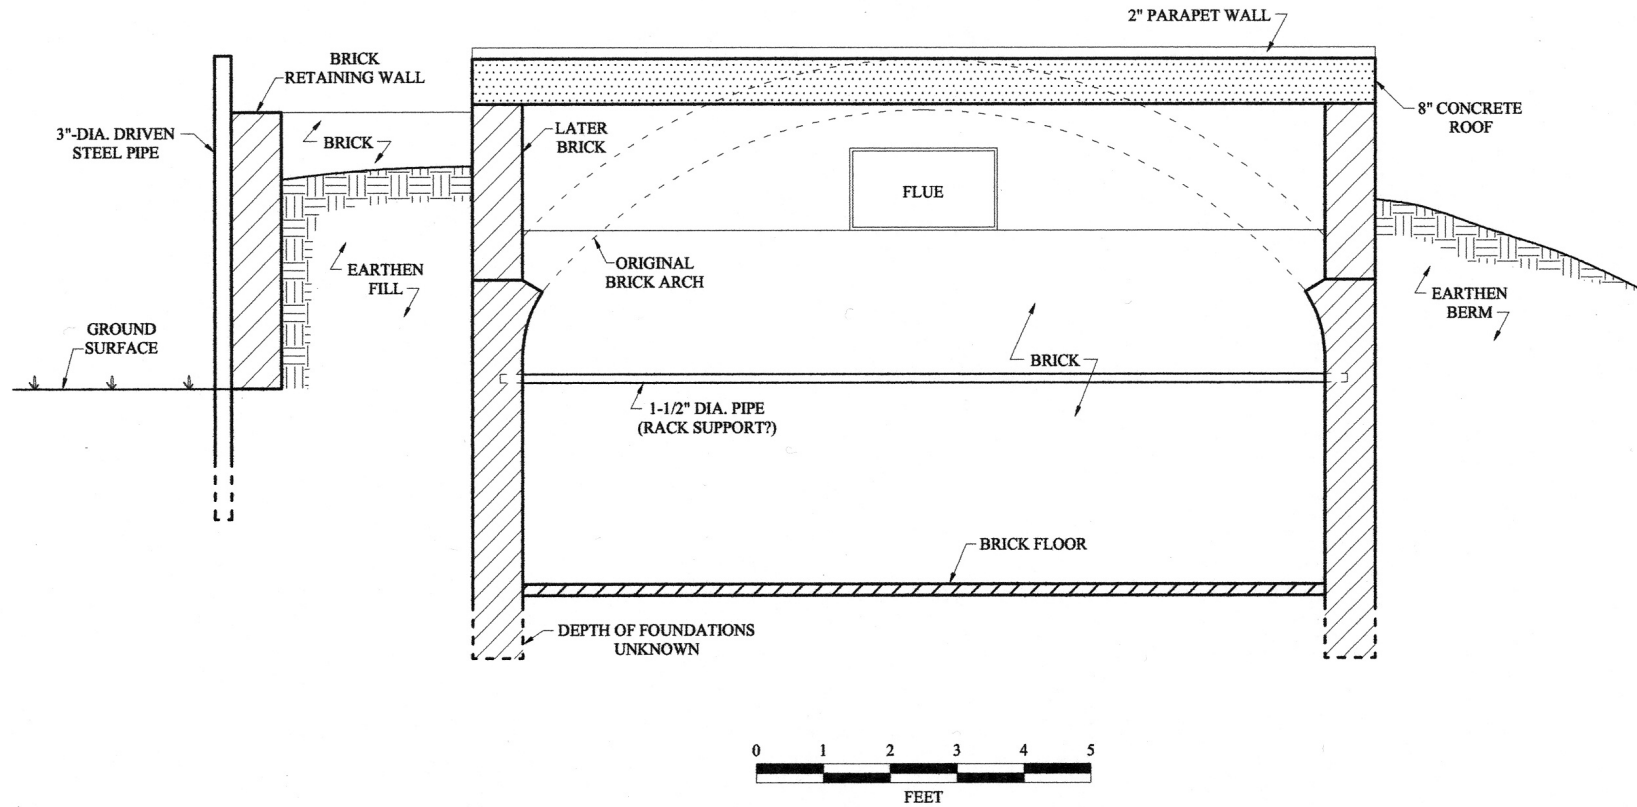
Figure 2. Sectional view through the root cellar looking north. The original barrel-arched ceiling on the cellar is indicated with dashed lines. This was replaced in 1913 by a flat concrete roof supported by straight walls.

1. Date(s) of Erection: The precise date of the root cellar's construction is not known. It is believed to date to the late nineteenth century (circa 1875-1900) during Balthaser Knobeloch's period of ownership.
2. Alterations and Additions: The original barrel-arched brick dome over the cellar was replaced by a flat concrete roof in 1913 by Julius Knobeloch. The lower 4'-3" of the original brick arch was retained, as was the brick floor.

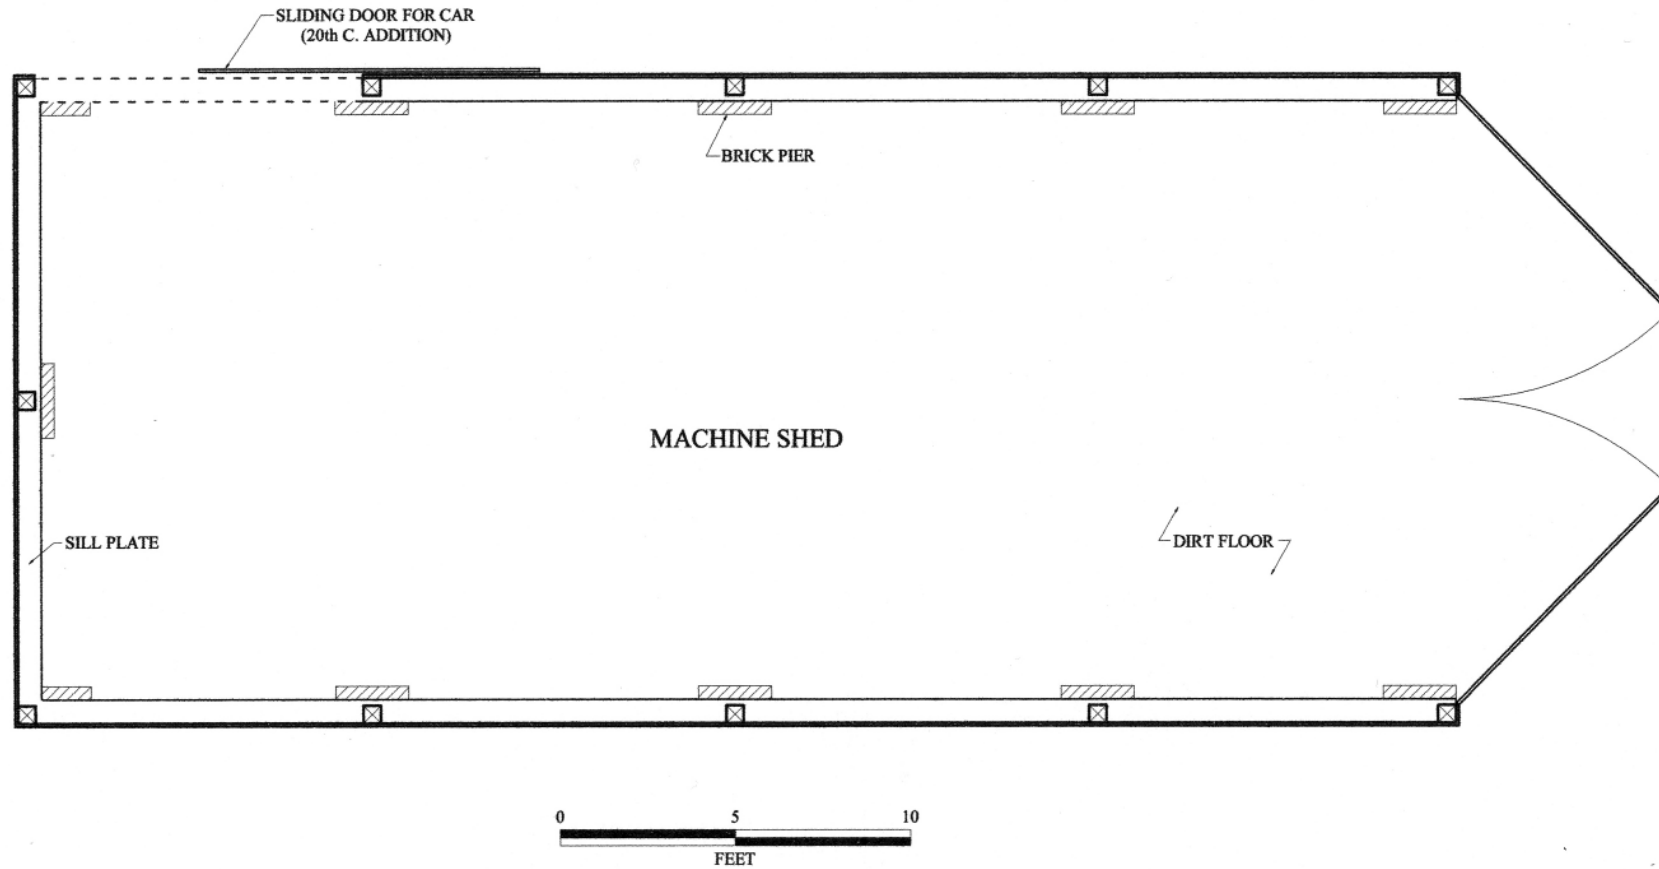
Figure 1. Floor plan of the early machine shed at the Moore-Knobelock Farmstead, showing conditions prior to its destruction in 2007.

1. Overall Dimensions: The building measured 18'-2" (north/south) by 41'-1" (east/west).
2. Foundations: The building rested in a series of large brick piers, which were positioned beneath the corner and wall posts. The piers were three courses (12") in width.

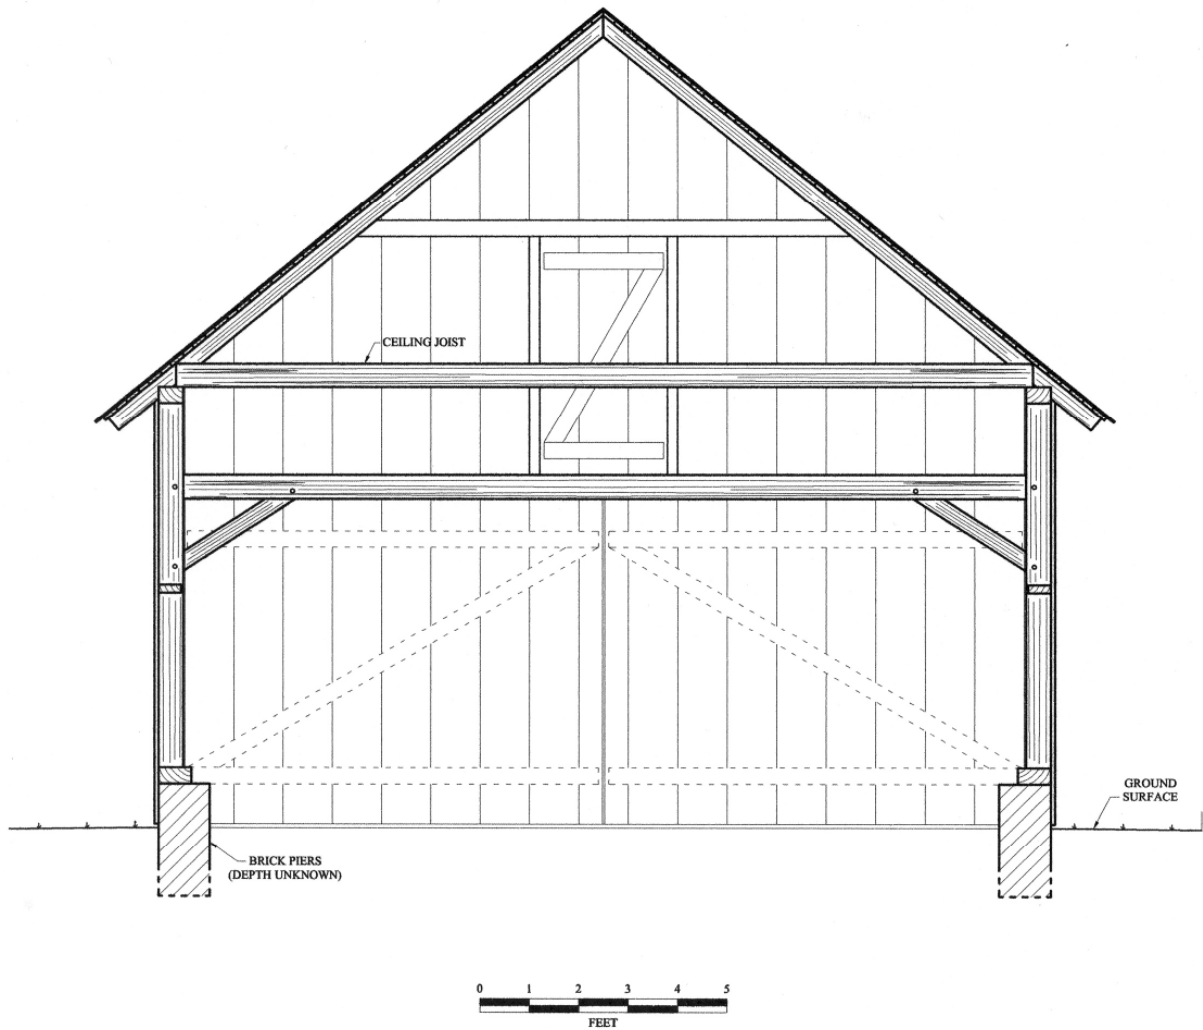
Figure 2. Sectional view of the early machine shed, showing east bent.
