Nettle Creek Aqueduct
NE1/4, NE1/4, NW1/4 of Section 9
Township 33 North, Range 7 East of the 3rd P.M.
Morris
Grundy County
Illinois

IL HAER No. GR-2014-1

ILLINOIS HISTORIC AMERICAN ENGINEERING RECORD
NETTLE CREEK AQUEDUCT

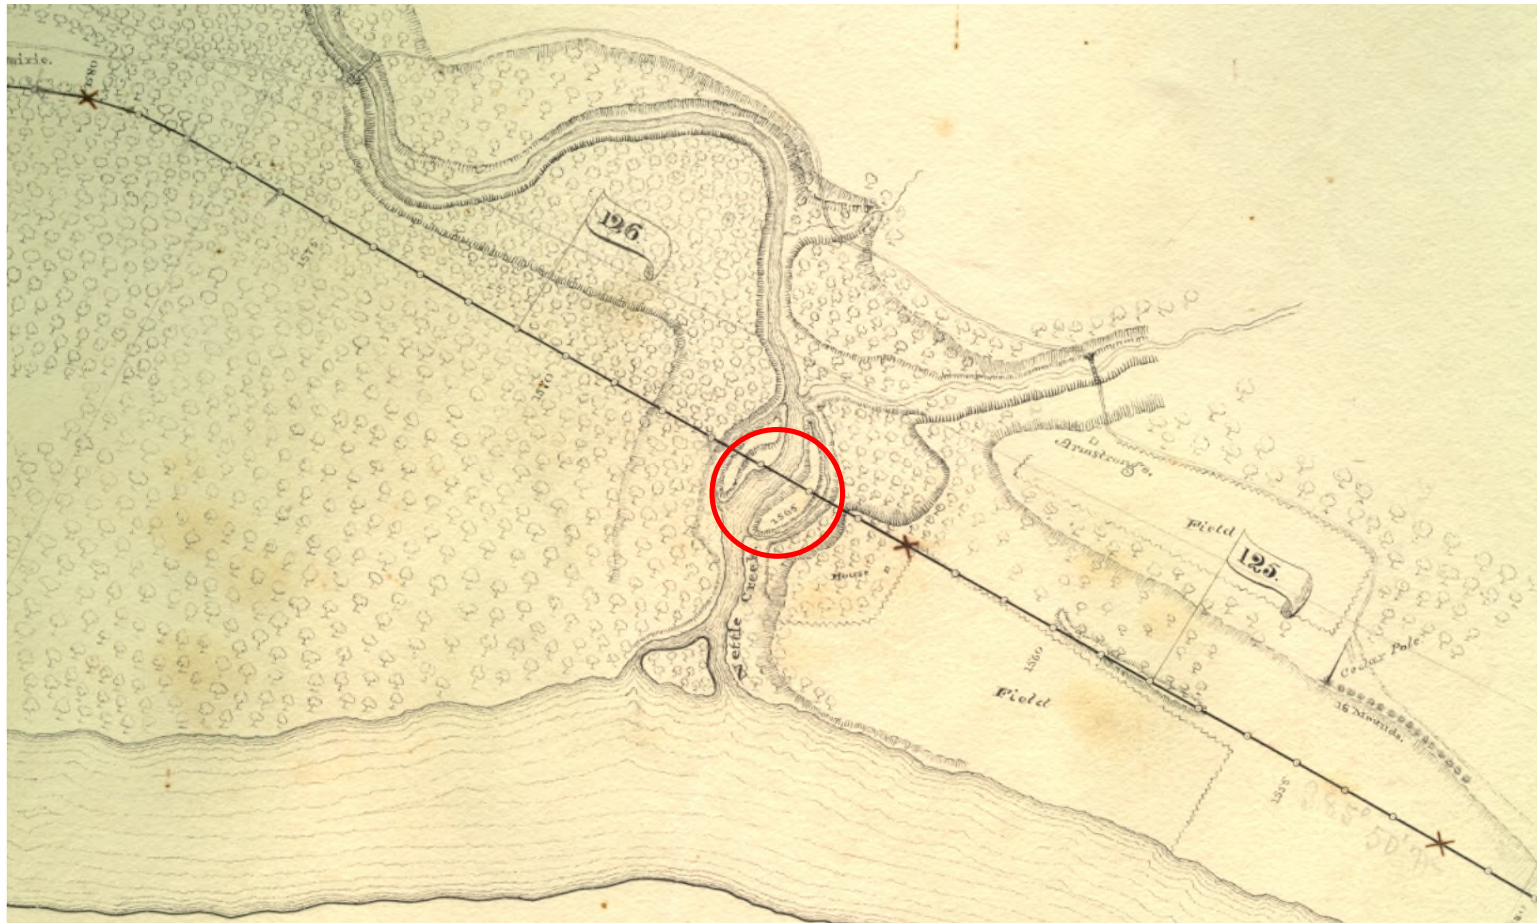
Detail of an 1841 map illustrating the surveyed route of the Illinois and Michigan Canal adjacent to Nettle Creek. The numbered flags on the map refer to the sections of the canal for which individual construction contracts were let. The map pre-dates the construction of the Nettle Creek Aqueduct. However, the structure's future location has been circled in red. This map provides a good depiction of settlement-era conditions immediately prior to the founding of Morris. The house labeled as "Armstrong's" to the east of the Nettle Creek, may have belonged to William E. Armstrong, who was awarded the contract for Section 125 and also participated in the construction of Section 126.

- GR-2014-1-S1 Detail of an 1841 map illustrating the surveyed route of the Illinois and Michigan Canal adjacent to Nettle Creek. The numbered flags on the map refer to the sections of the canal for which individual construction contracts were let. The map pre-dates the construction of the Nettle Creek Aqueduct. However, the structure's future location has been circled in red. This map provides a good depiction of settlement-era conditions immediately prior to the founding of Morris. The house labeled as "Armstrong's" to the east of the Nettle Creek, may have belonged to William E. Armstrong, who was awarded the contract for Section 125 and also participated in the construction of Section 126, as well that of the original aqueduct over Nettle Creek.¹

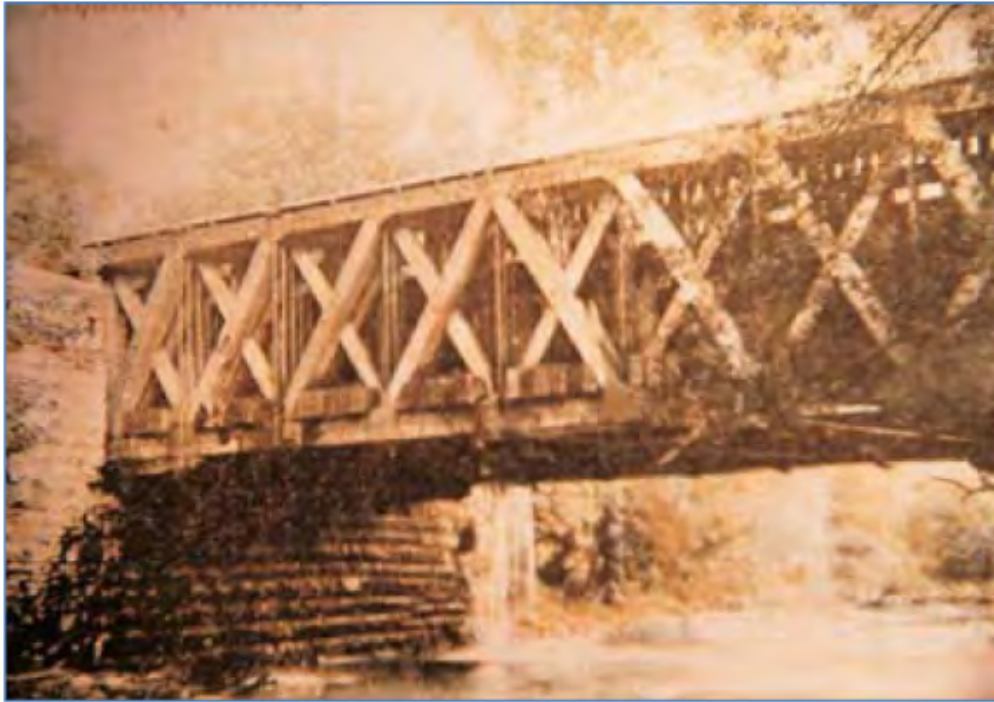
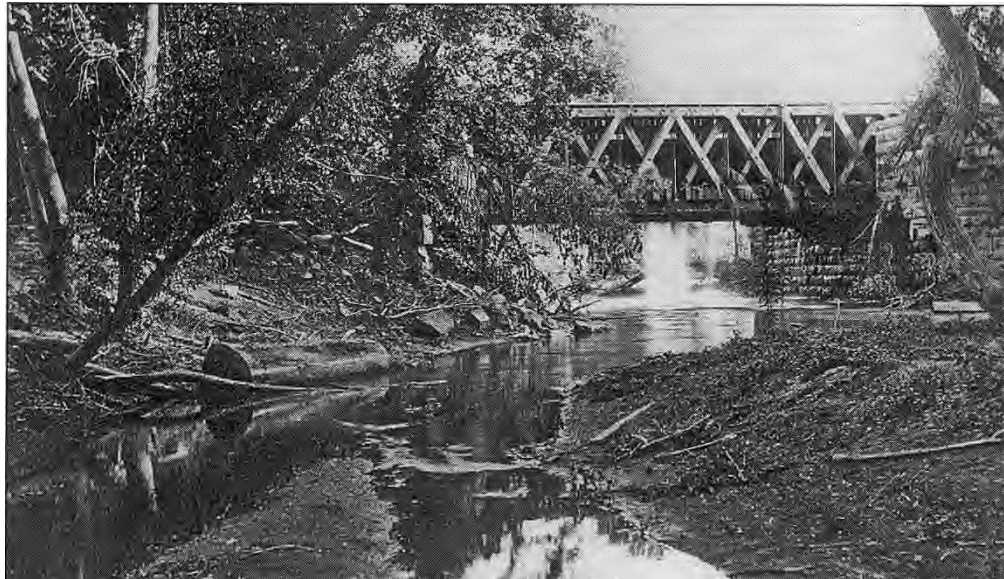
Two historic photographs of the Nettle Creek Aqueduct (looking south), likely dating from the late nineteenth century. These images capture the essence of the aqueduct's early design, with a frame trunk carried by a Howe Truss between two stone abutments. However, the structure actually had been rebuilt several times over by this point due to a series of devastating flood episodes and general decay. Note the ashlar stonework and regular coursing used for the abutments.

- GR-2014-1-S6 Two historic photographs of the Nettle Creek Aqueduct (looking south), likely dating from the late nineteenth century. These images capture the essence of the aqueduct’s early design, with a frame trunk carried by a Howe Truss between two stone abutments. However, the structure actually had been rebuilt several times over by this point due to a series of devastating flood episodes and general decay. Note the ashlar stonework and regular coursing used for the abutments.⁶

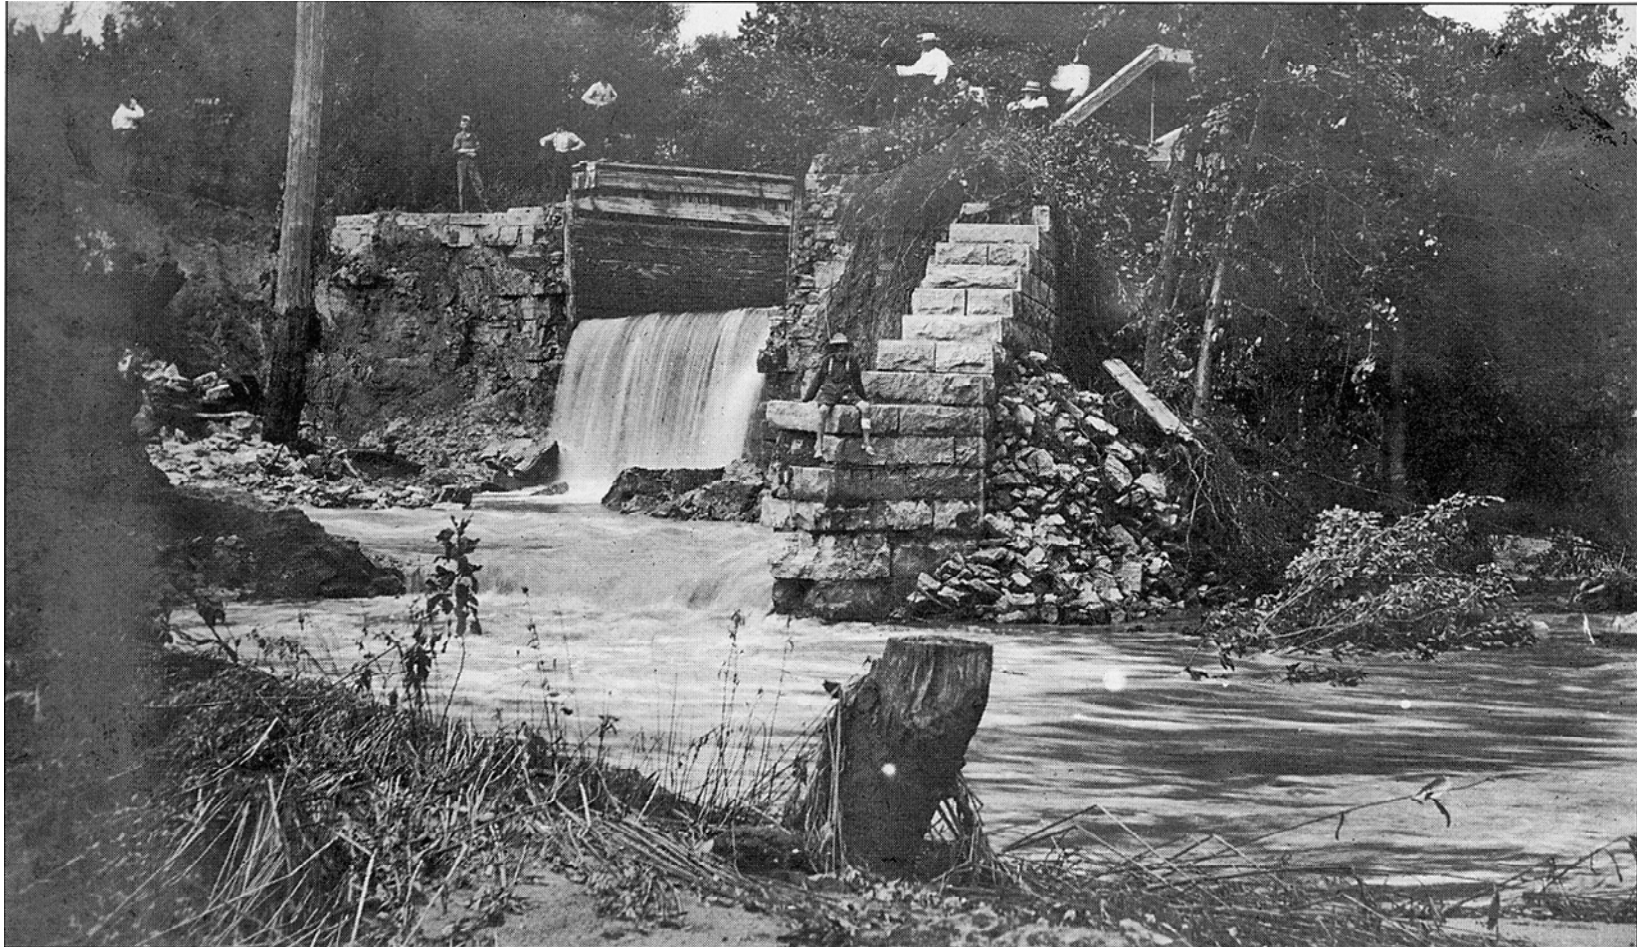
Another view of the Nettle Creek Aqueduct after the break in the canal in the spring of 1910. This image provides a good illustration of the manner in which the abutment wing walls were constructed.

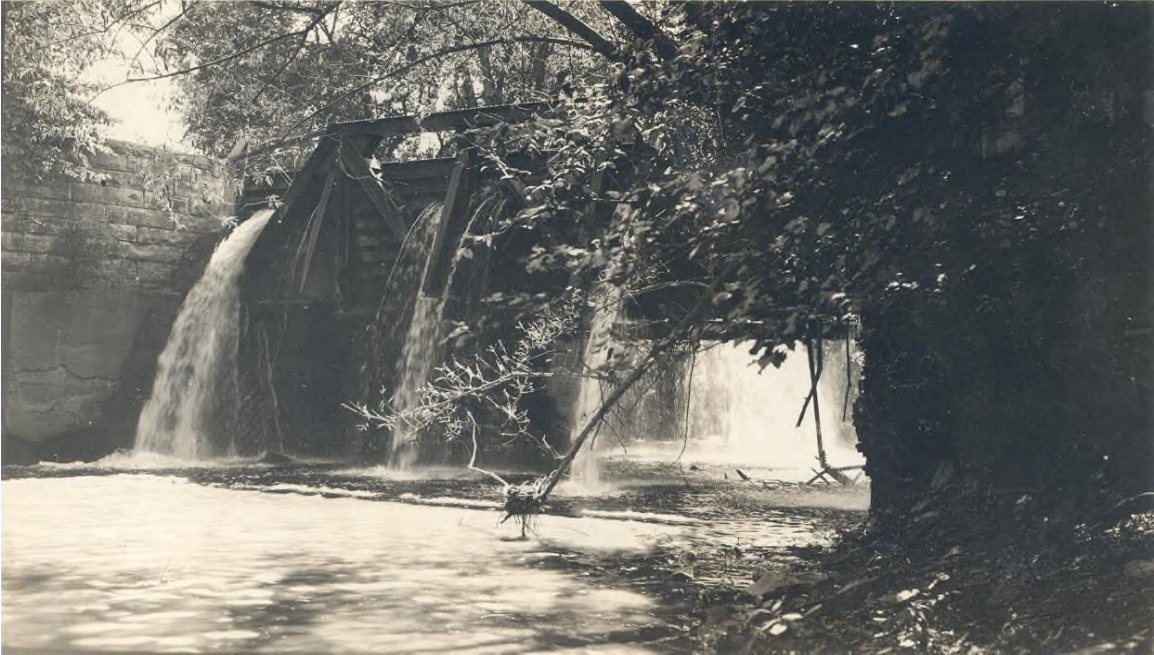
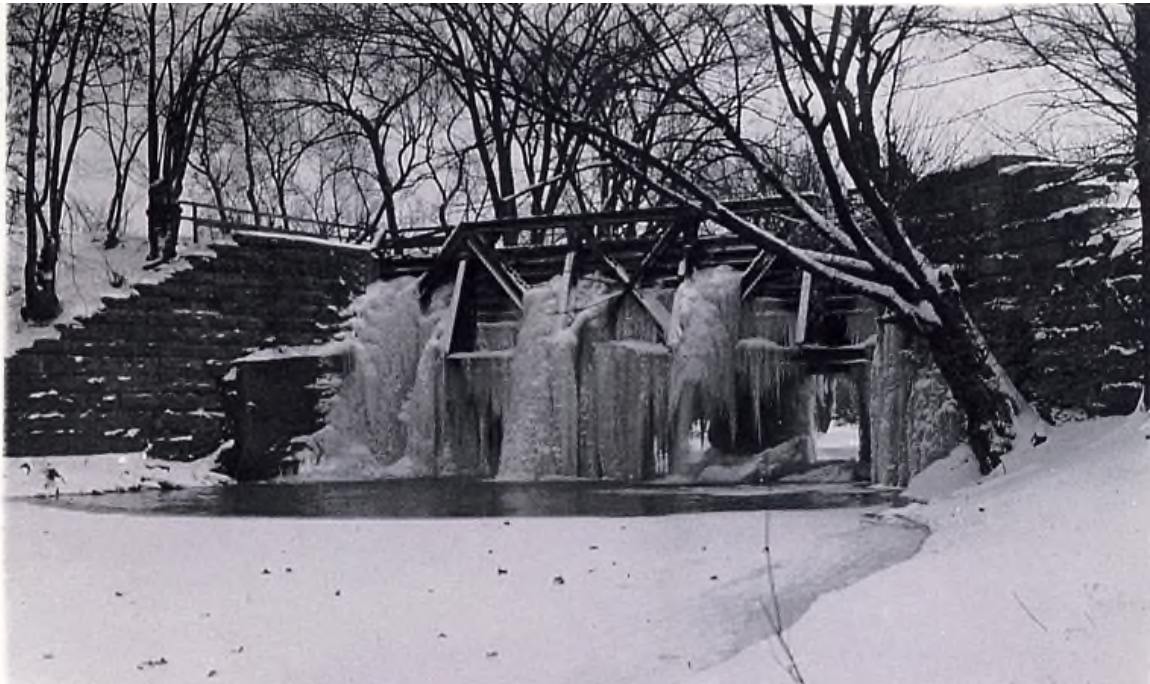
Two views of the Nettle Creek Aqueduct showing the steel-frame structure that was installed in 1910. These photographs are undated but possibly were taken in the 1920s or early 1930s (based on the drastic leaks in the aqueduct's trunk). Both views show the north side of the aqueduct and look southeast. Note the addition of poured concrete along the lower part of the east abutment.

- GR-2014-1-S9 Two views of the Nettle Creek Aqueduct showing the steel-frame structure that was installed in 1910. These photographs are undated but possibly were taken in the 1920s or early 1930s (based on the drastic leaks in the aqueduct’s trunk). Both views show the north side of the aqueduct and look southeast. Note the addition of poured concrete along the lower part of the east abutment.⁹

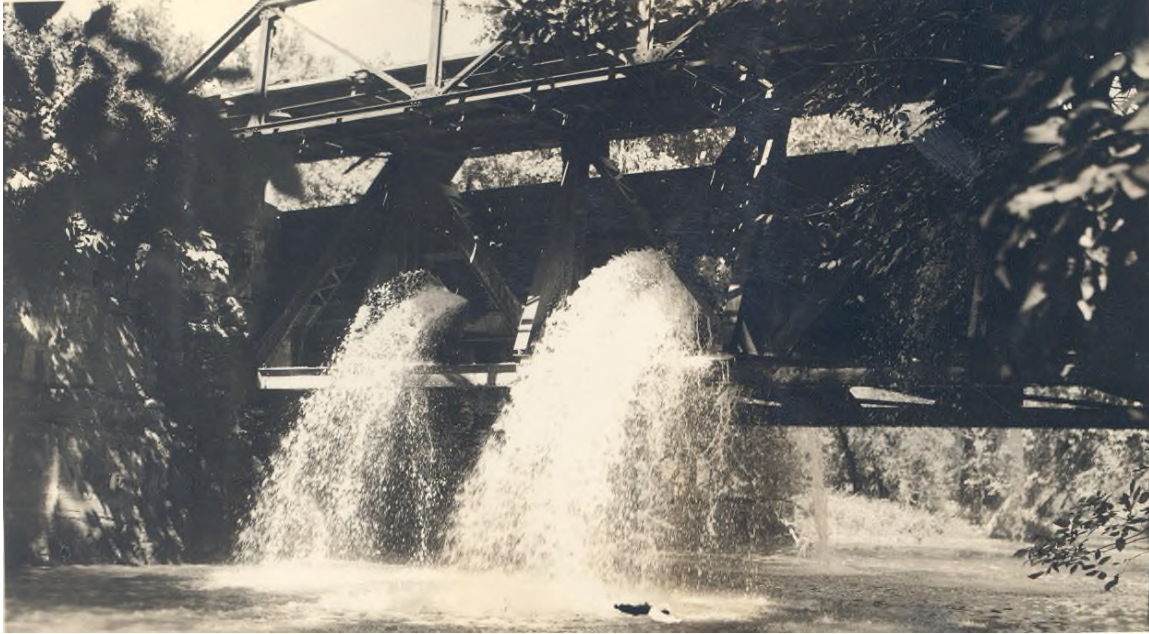
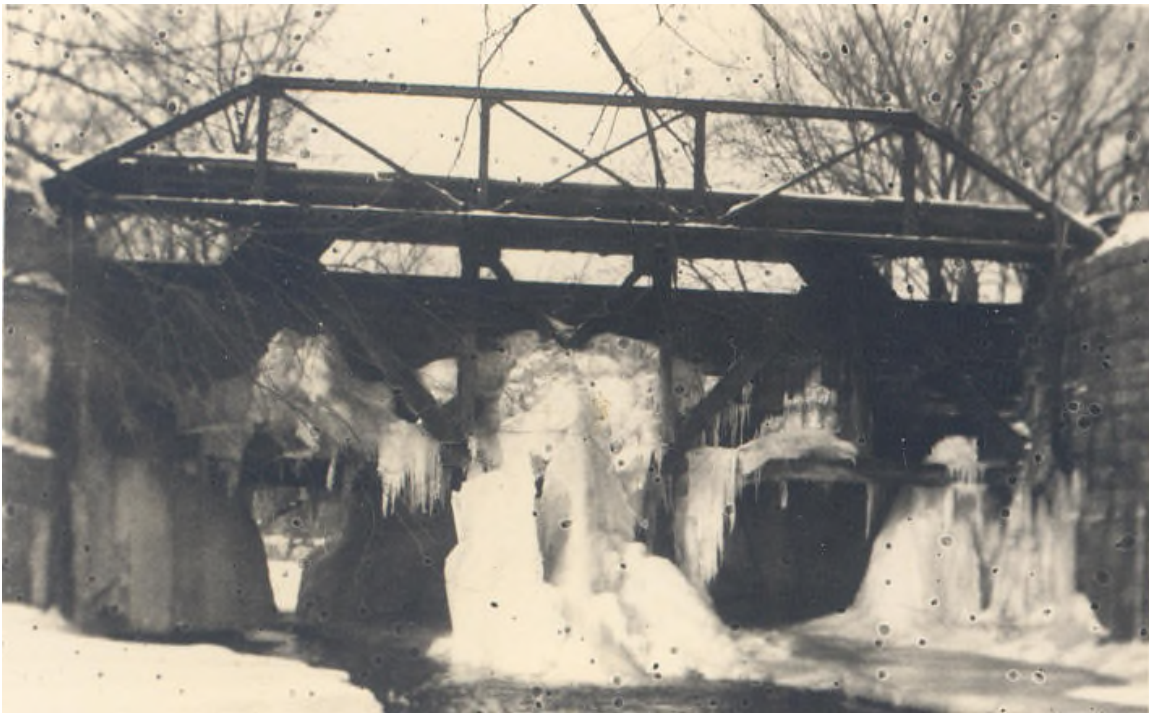
Two other undated photographs of the steel-frame aqueduct over Nettle Creek, possibly taken in the 1920s or early 1930s. Both views show the south side of the aqueduct and illustrate the vehicle bridge here. The downstream side of the bridge deck was carried by the Pratt Pony Truss.

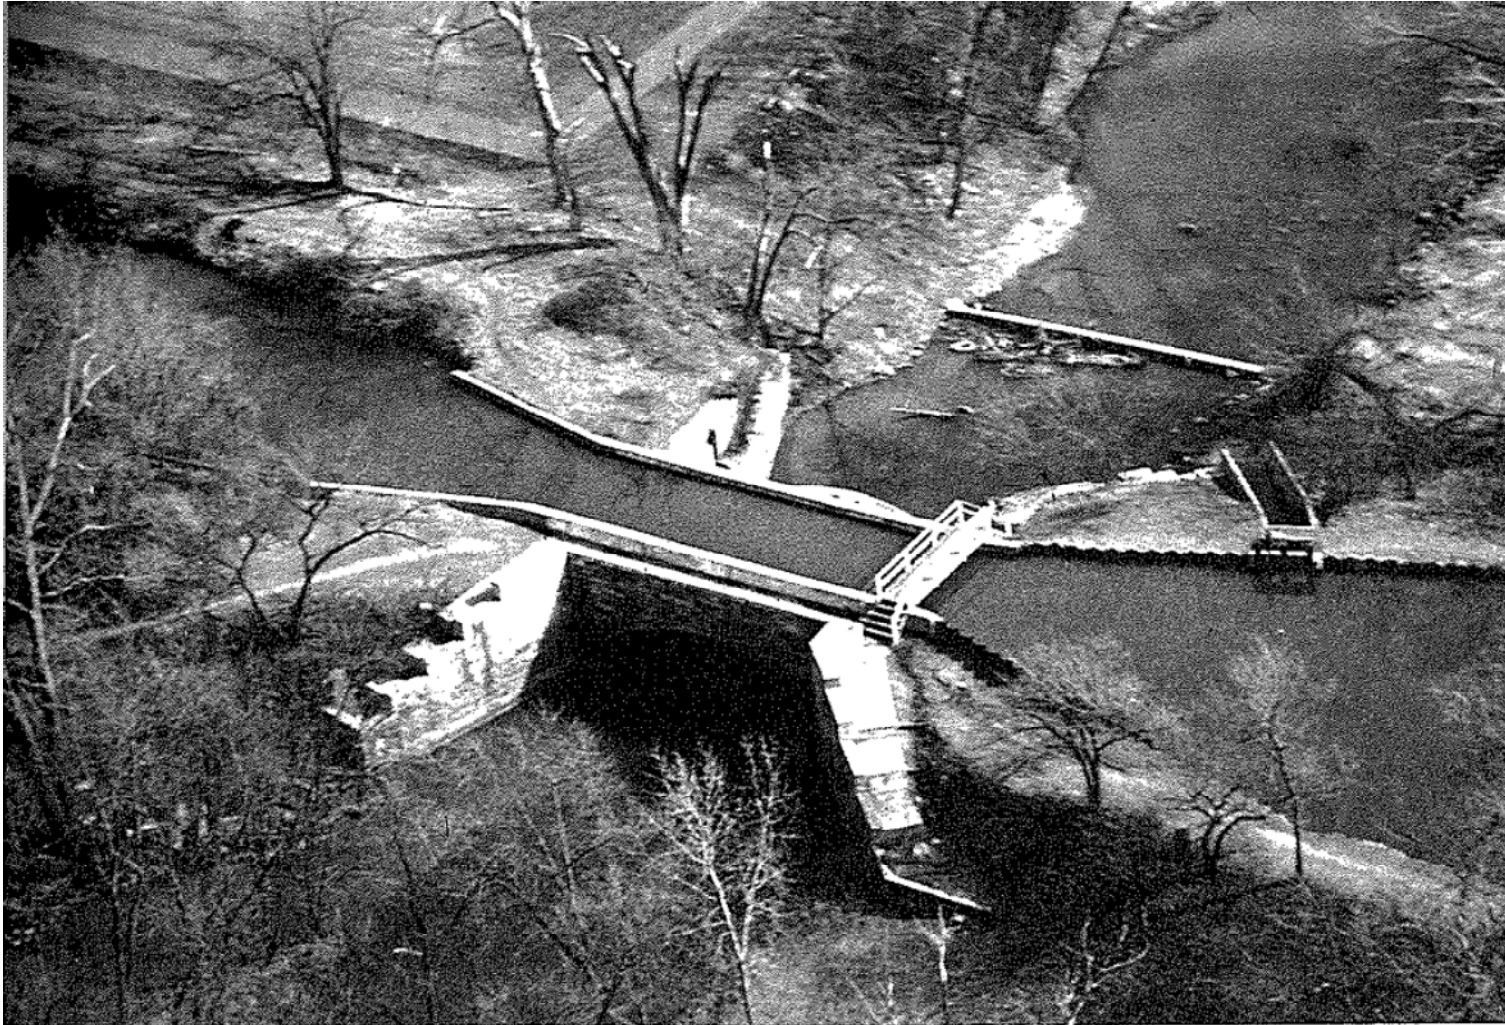
Photograph of the Nettle Creek Aqueduct, taken circa 1974. By this date, the bridge deck on the south side of the aqueduct apparently had been removed.

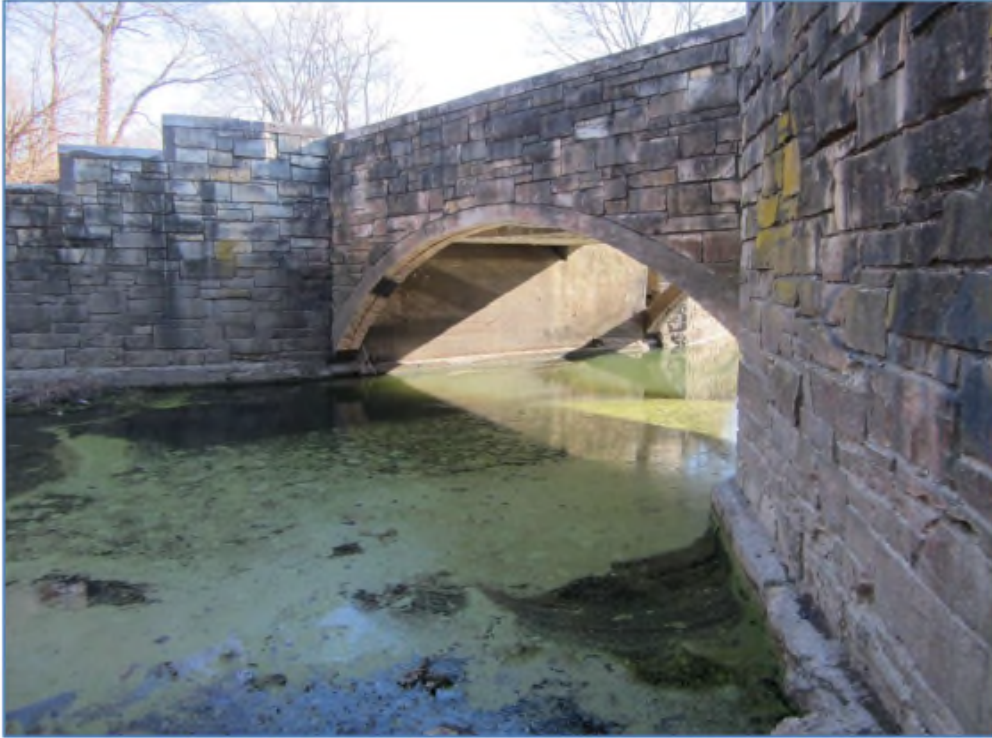
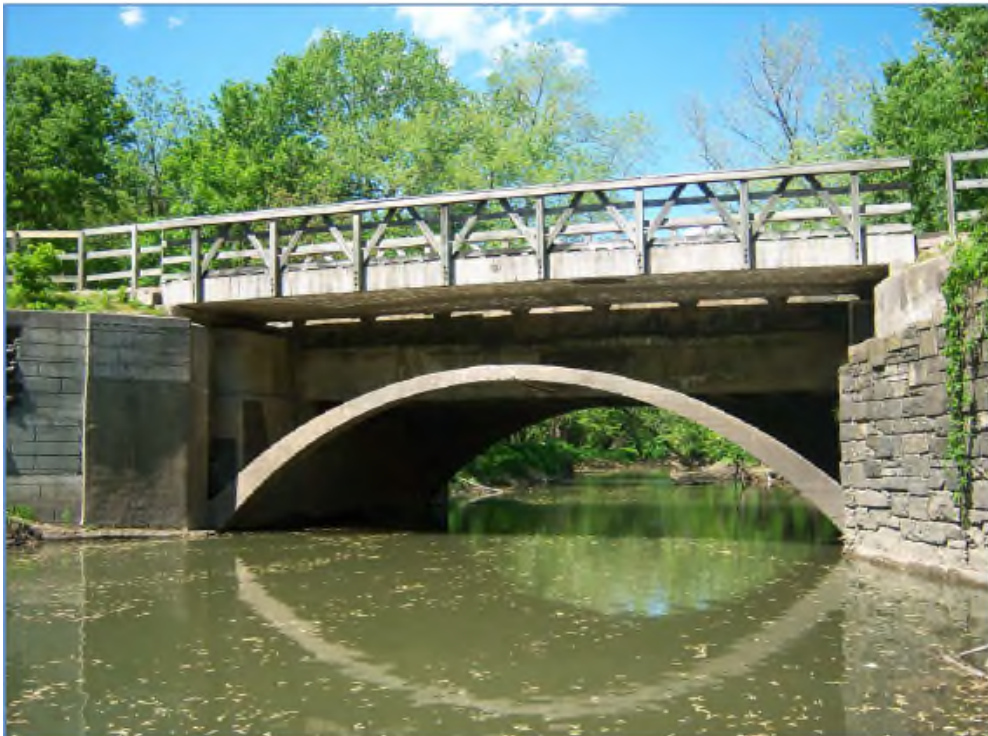
Modern-day views of the Nettle Creek Aqueduct, showing conditions prior to the 2013 flood event. (TOP) View of the north elevation in 2012. (BOTTOM) View of the south elevation in 2009.

- GR-2014-1-S36 *I & M Canal Rehabilitations, Nettle Creek Aqueduct—Details* (1997).³⁶
- GR-2014-1-S37 Modern-day views of the Nettle Creek Aqueduct, showing conditions prior to the 2013 flood event. (TOP) View of the north elevation in 2012. (BOTTOM) View of the south elevation in 2009.³⁷

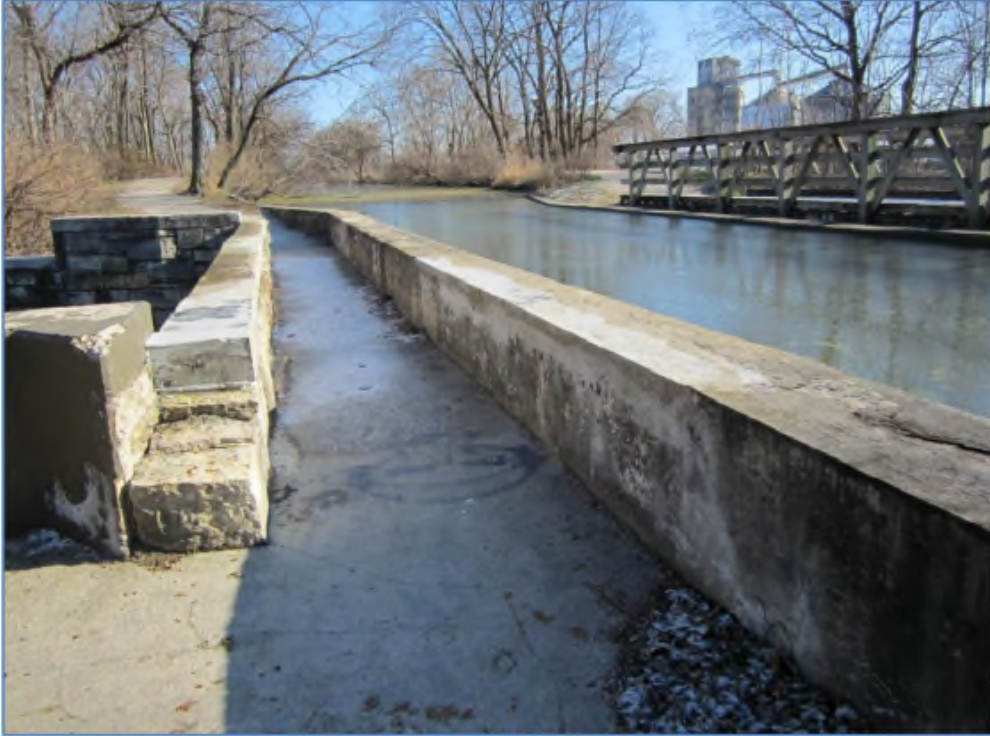
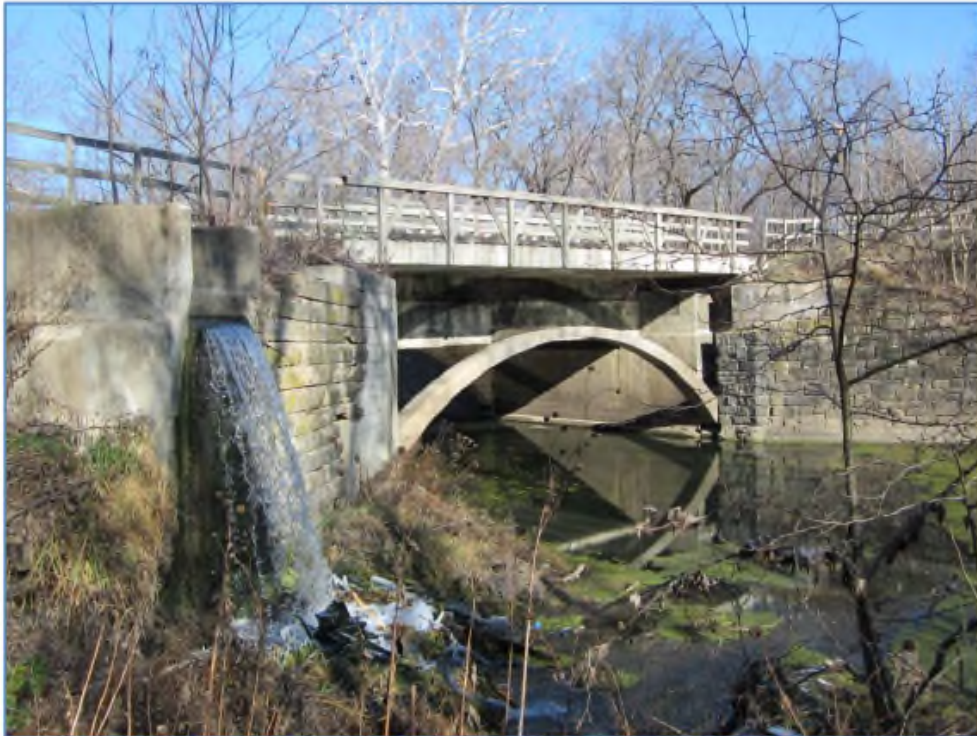
Additional modern-day views of the aqueduct, showing pre-2013 conditions. (TOP) View looking east along the pedestrian walkway and trunk. (BOTTOM) View of the south elevation, looking northeast. The spillway can be seen at left.

- GR-2014-1-S38 Additional modern-day views of the aqueduct, showing pre-2013 conditions. (TOP) View looking east along the pedestrian walkway and trunk. (BOTTOM) View of the south elevation, looking northeast. The spillway can be seen at left.³⁸

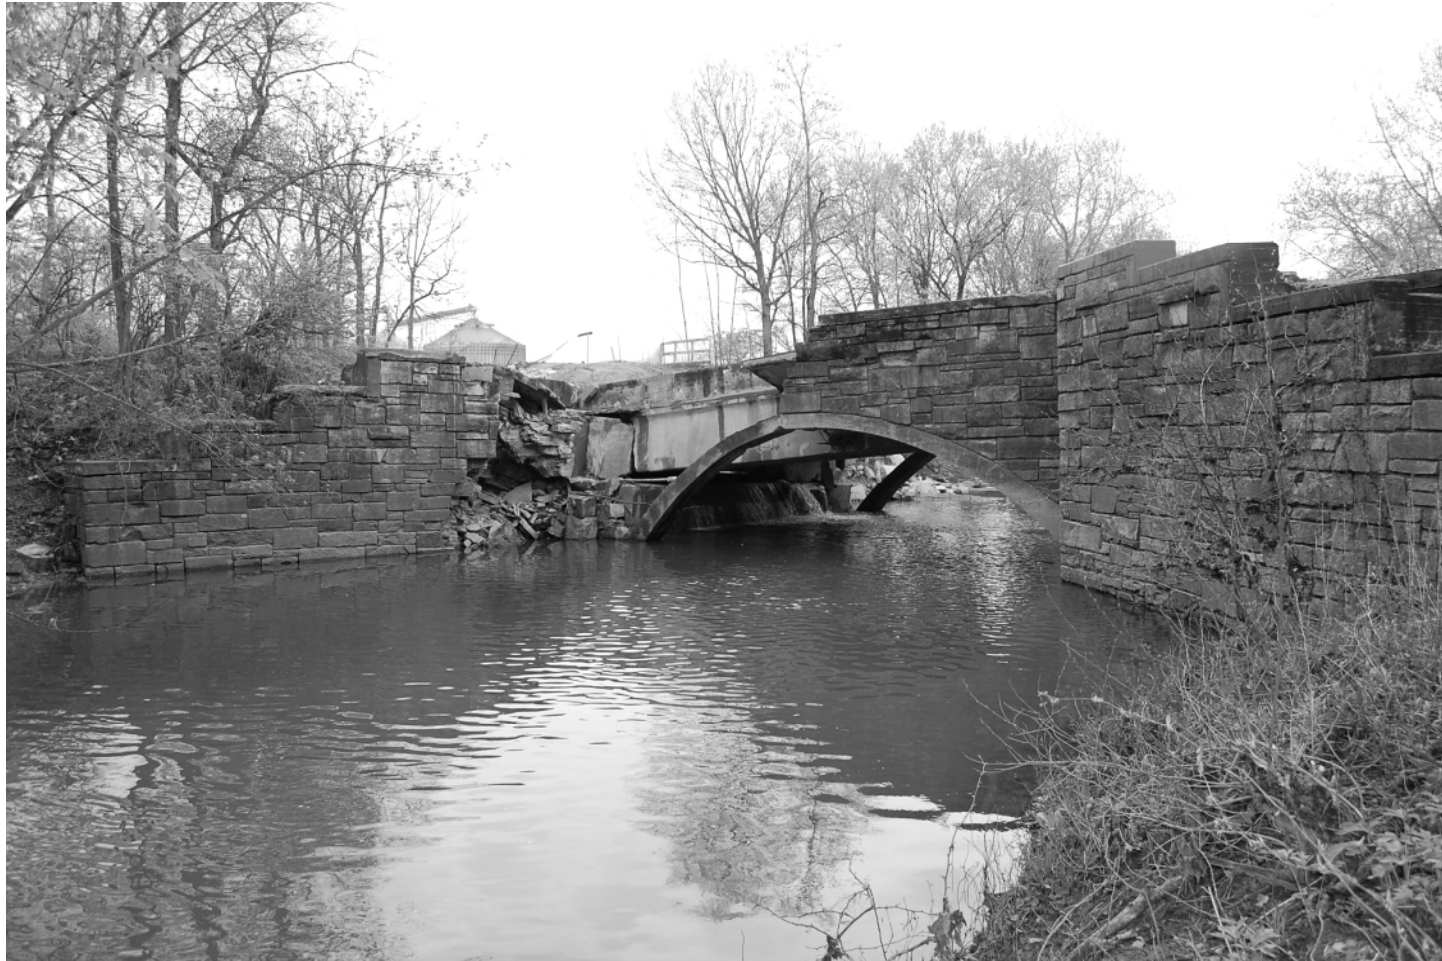
- GR-2014-1.1 View of the Nettle Creek Aqueduct looking southeast from the west bank of Nettle Creek. Note the significant flood damage on the east end of the structure (Frame 8533).

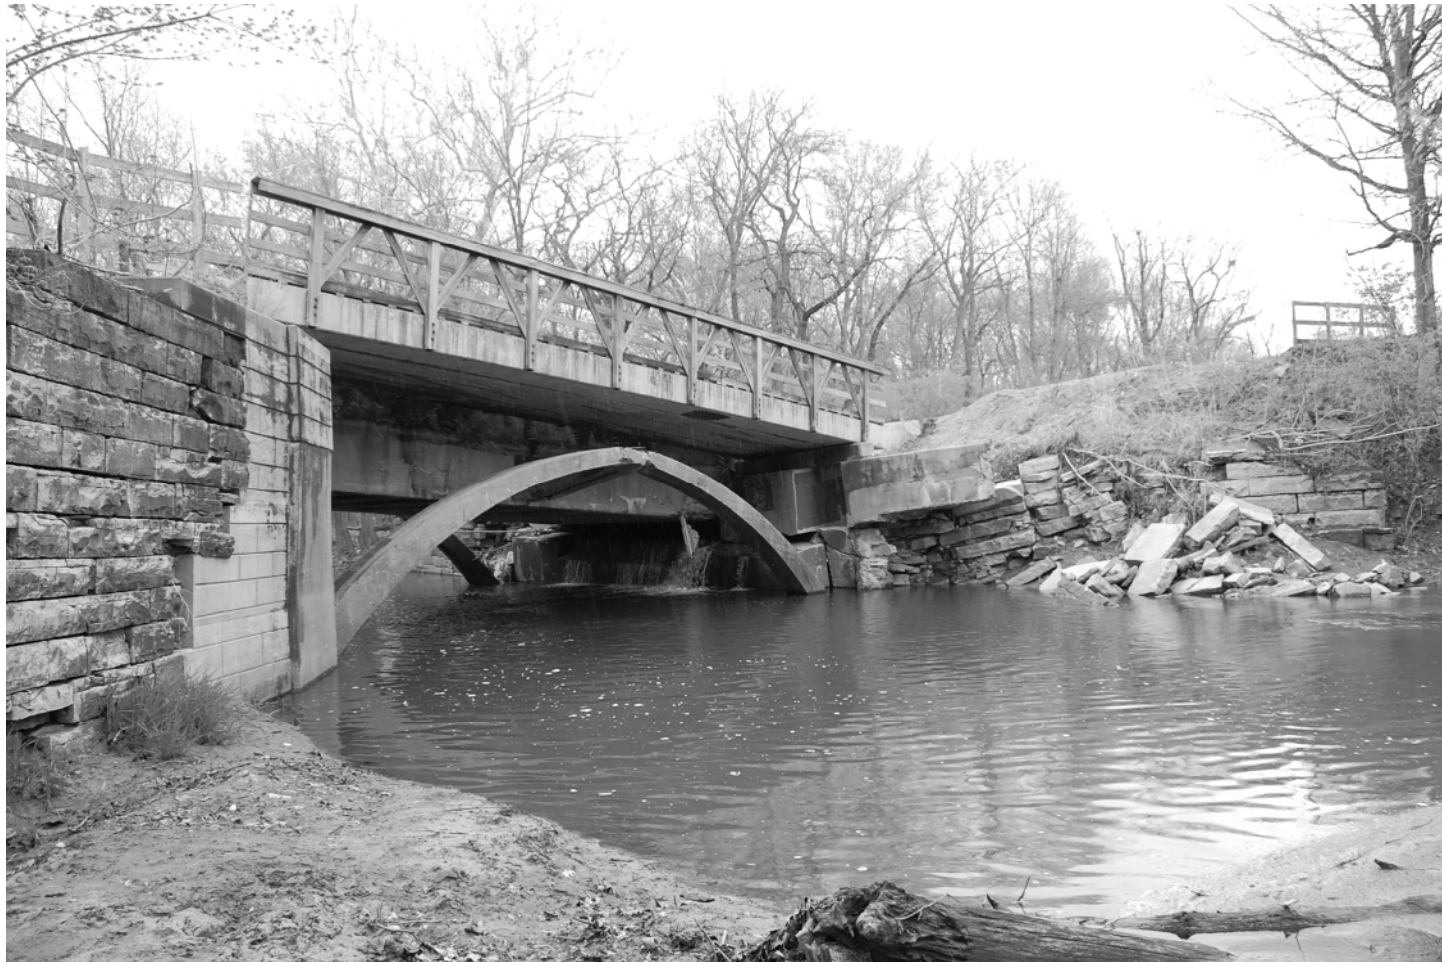
- GR-2014-1.2 View of the aqueduct looking northeast from the west bank of Nettle Creek. This view shows the vehicle bridge on the south side of the aqueduct and also illustrates the severe damage suffered by the east abutment's southern wing wall (Frame 8495).

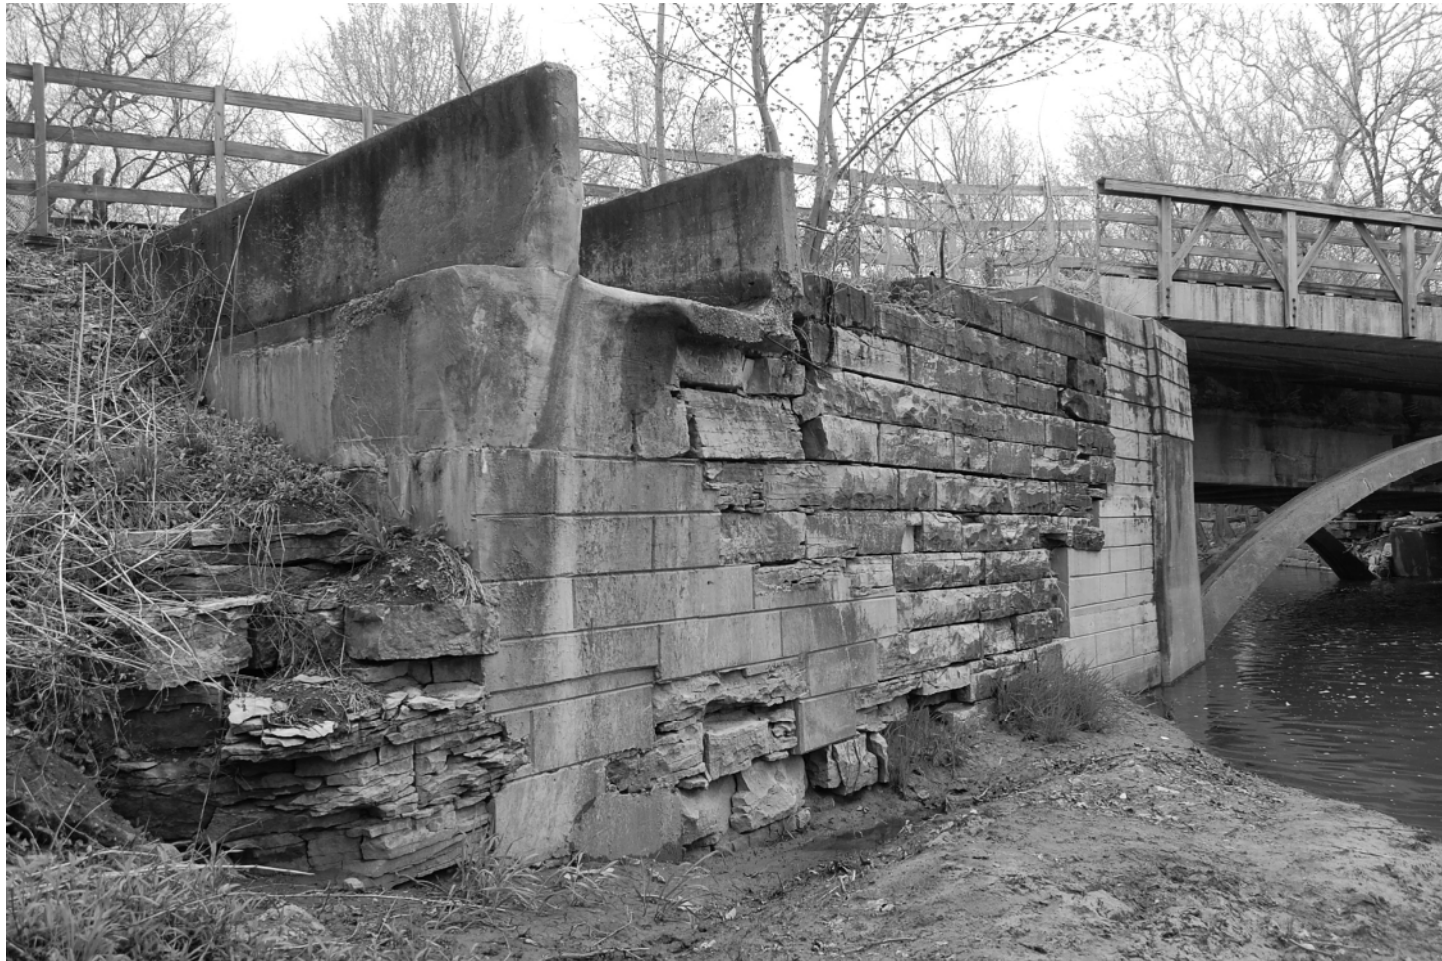
GR-2014-1.19

View of the discharge end of the spillway, which straddles the southern end of the west abutment. Note shotcrete repairs made to the stonework below the spillway (Frame 8493).
