HISTORIC PHOTOGRAPH

# Mercer Co. Senior Center

137 West Main St Aledo

PROPOSED DESIGN

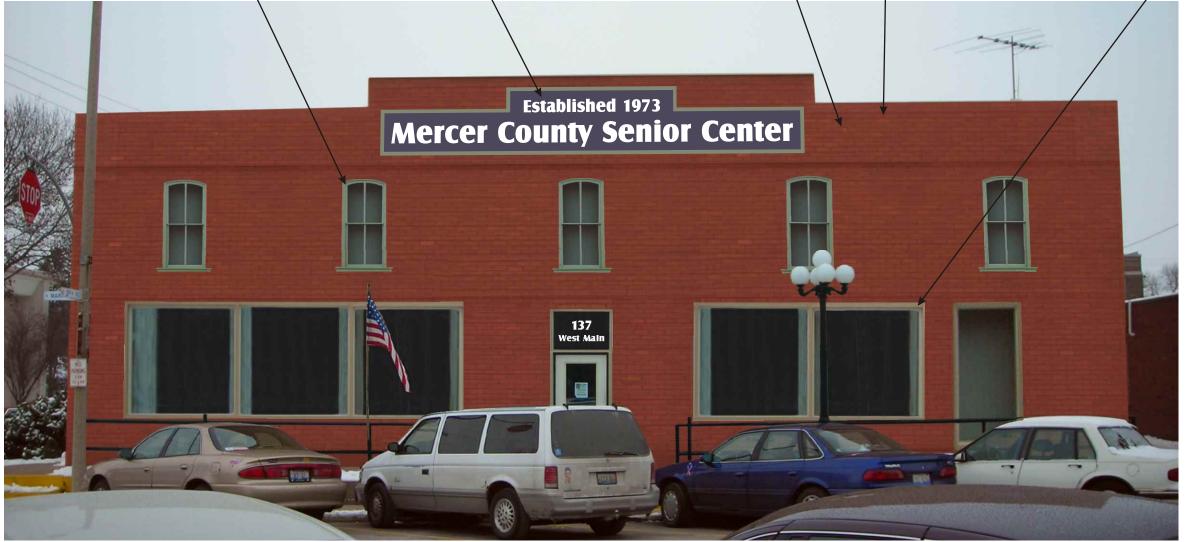
A new larger flush mounted sign

should installed on the building.

If historic upper-floor windows are still remaining they

should be repaired. If historic windows are no longer

remaining, new windows matching the historic

windows shape, size and profile should be installed.

Remove synthetic siding and brick from building facades.

-Remove sign from building.

Where needed, historic brick should be repointed with a mortar that closely matches the historic mortar in composition, color, and joint profile.

Building should be painted a color that closely matches the historic brick color. Any existing lose paint should be scraped off with a nylon bristle brush before repainting.

New storefront windows that match the size and shape of the historic storefront windows should be installed. Larger windows are more historically appropriate for the building.
