PROPOSED DESIGN

Sensei Steve's Karate Center

118 East Washington
Momence

Drawn by AMB	July, 2008
Project Number 2008046	Sheet 1 of 1

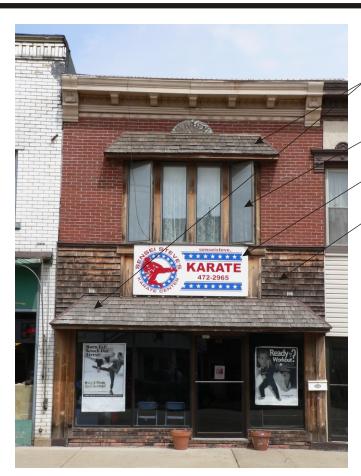
EXISTING CONDITIONS

Existing shingle canopies should be removed.

Upper-floor windows should be removed.

Existing sign should be removed.

Shingles at transom area should be removed.

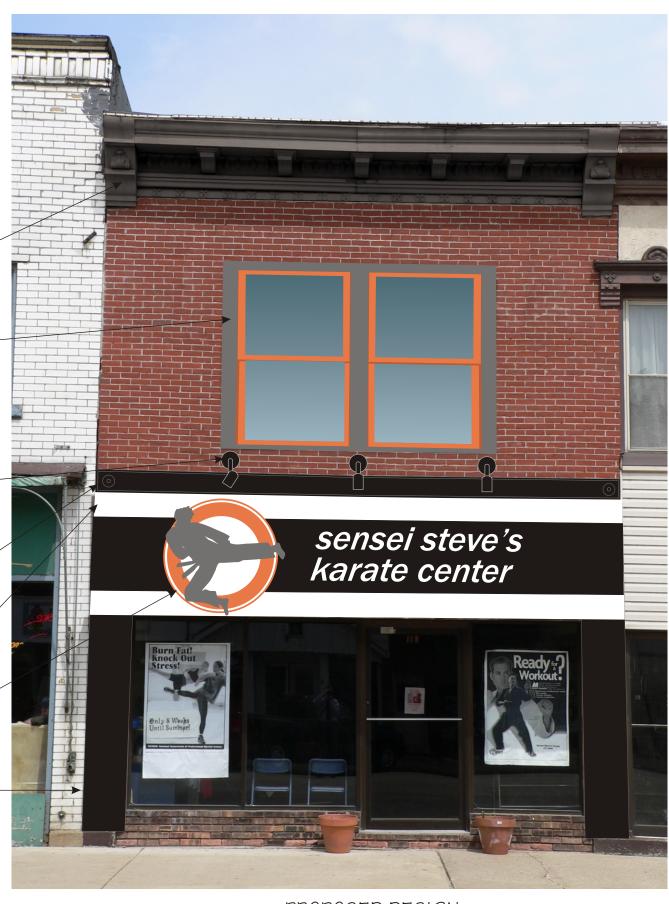
Metal cornice should be scraped with a wire brush to remove lose paint and rust, then primed and repainted Cityscape (SW 7067) from Sherwin Williams Paints.

Two new double-hung windows should be installed in existing opening. Window frames should be painted to match colors used in sign. Double-hung windows are more historically appropriate than the current casement windows.

Three new light fixtures directed down should be installed below the new windows. The light fixtures—should be contemporary in style with a black finish. An example is Sign Star Style C (MR-16) from B-K Lighting.

The existing steel lintel should be scraped with a wire brush to remove lose paint and rust, then primed and painted black.

Cement board should be installed under the steel lintel and above the storefront display windows to cover the transom area. The cement board should be painted white and should extend across the face of the building.

New signage should be installed on the cement board. The new signage is two parts; one horizontal black sign that extends across the white cement board with vinyl graphics "sensei steve's karate center" in white italicized font; and a circular sign attached over the black horizontal sign with vinyl graphics of the updated logo.

The wood panels should be painted black to disguise the non-historic fabric.

The existing logo has been updated. The silhouette is clearer and more dynamic. The stars have been removed because they cluttered the logo and made it difficult to read. The logo is now on a horizontal band that implies a black belt. The font is lower case to be more stylish, and it is italicized to imply movement.

This rendering is based on the assumption that no historic fabric remains under the existing nonhistoric fabric. If historic fabric is uncovered, contact IHPA and we will revise the rendering accordingly.
